**TOPANGA RANCH MOTEL**  
**Condition Assessment and Conceptual Design for**  
**Rehabilitation**

**Topanga Ranch Motel**  
**18711 Pacific Coast Highway**  
**Malibu, CA 90265**

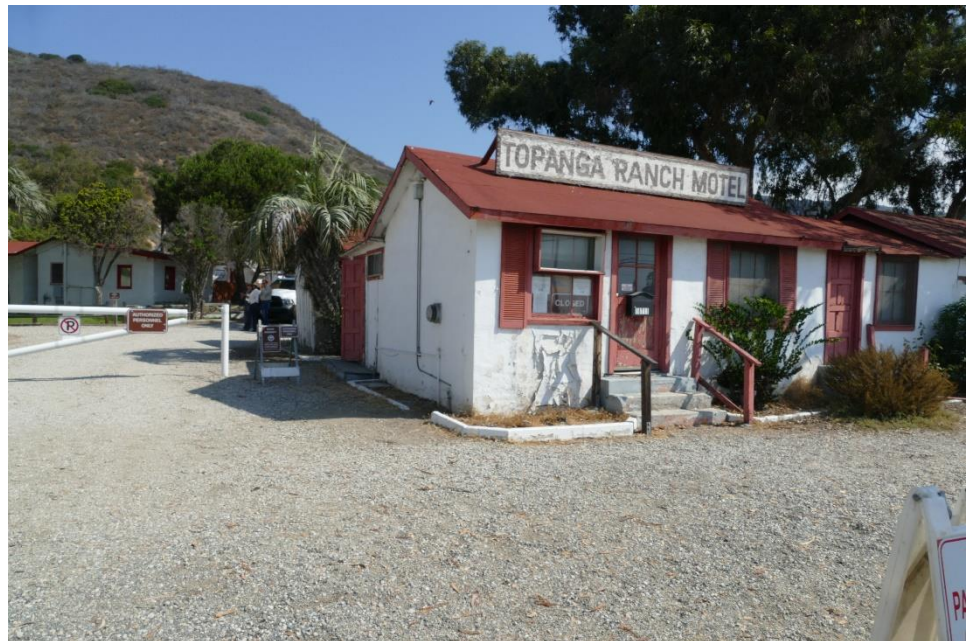
**Draft Report**  
January 11, 2019  
WJE No. 2018.1868

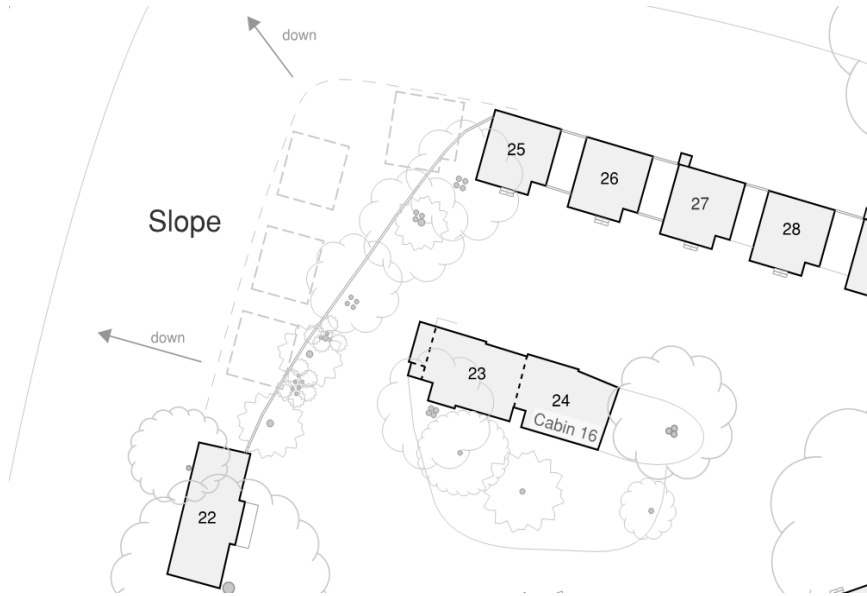
Figure 7. Northwest corner of the building site, where as many as four additional buildings were located according to historic aerial photos. These buildings have been removed due to erosion of the earthen embankment in this area.

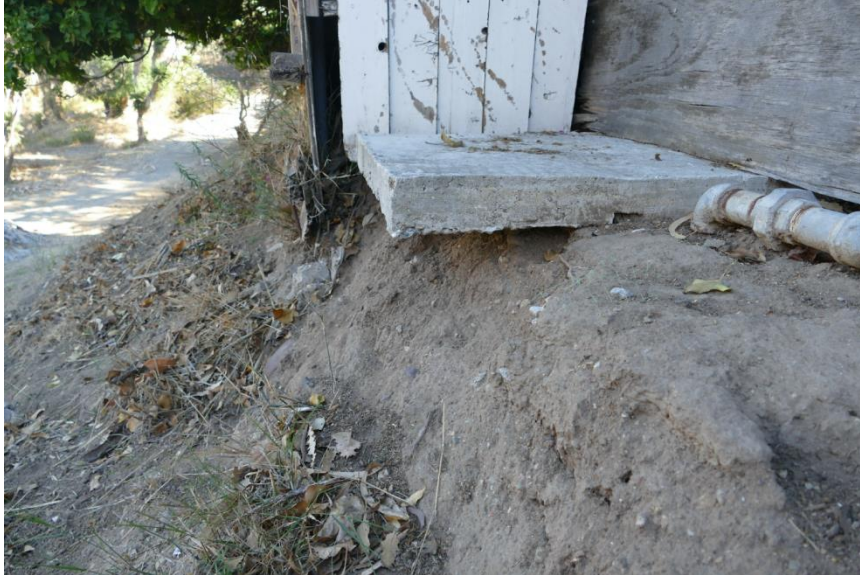
Figure 17. Northeastern embankment failure, undermining a slab on ground. Photo taken facing southeast.

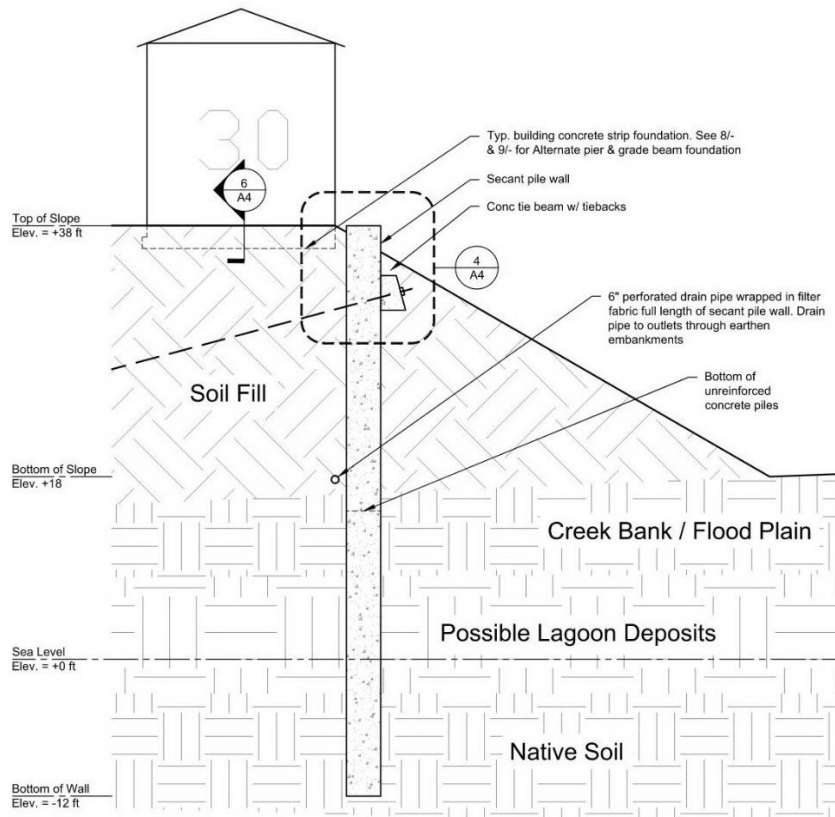
Figure 18. Conceptual design for concrete secant pile retaining wall.

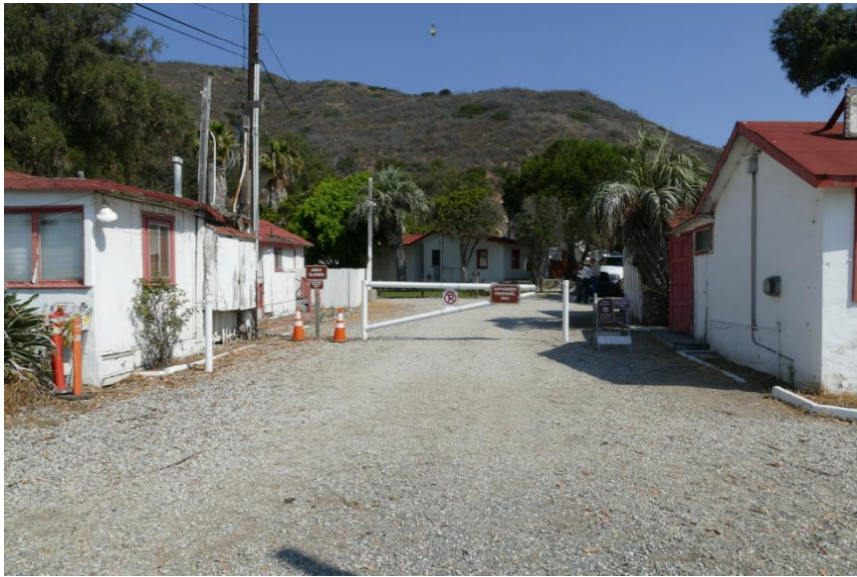
*Figure 35. Main entry driveway bisecting the South Row West and South Row East groupings. Photo taken facing northwest.*

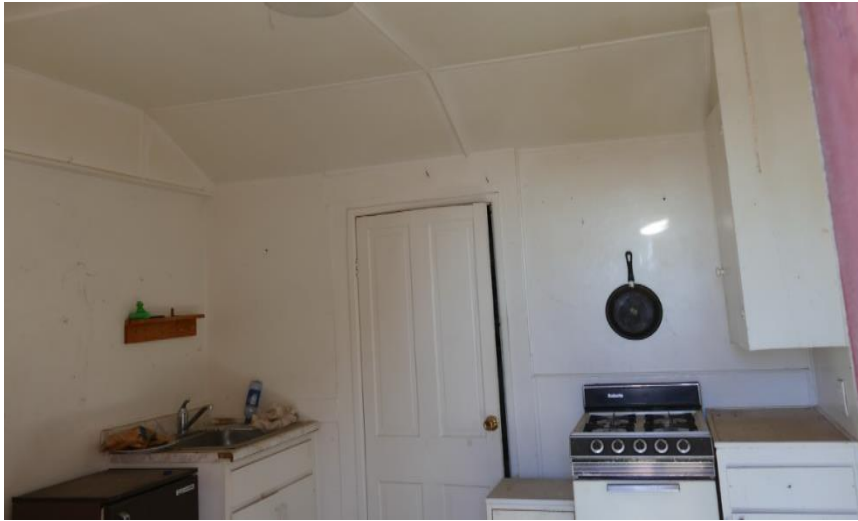
*Figure 41. Typical kitchenette found within the South Row East units in the living rooms (Unit 14 used as an example). Photo taken facing northwest.*

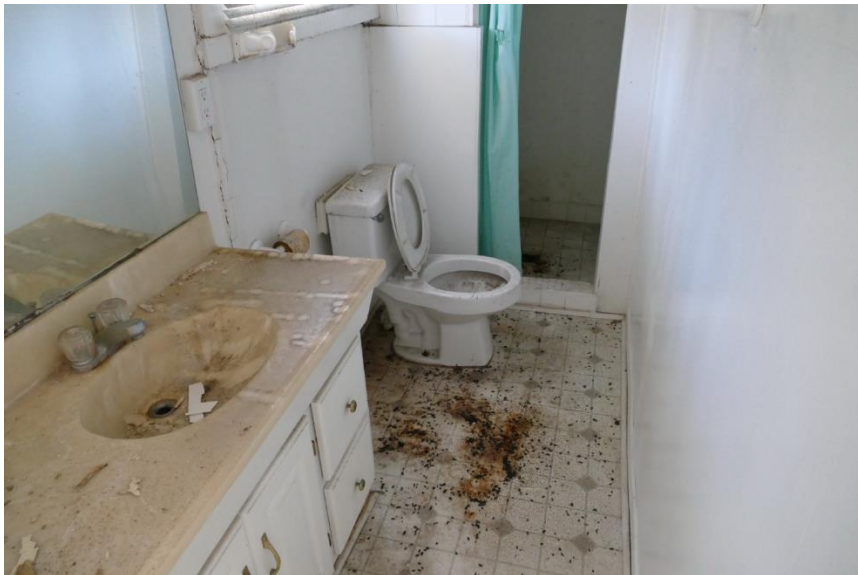
*Figure 42. Typical narrow attached bathroom extending across the rear of each unit in the South Row East group (Unit 12 used as an example). Photo taken facing northeast.*

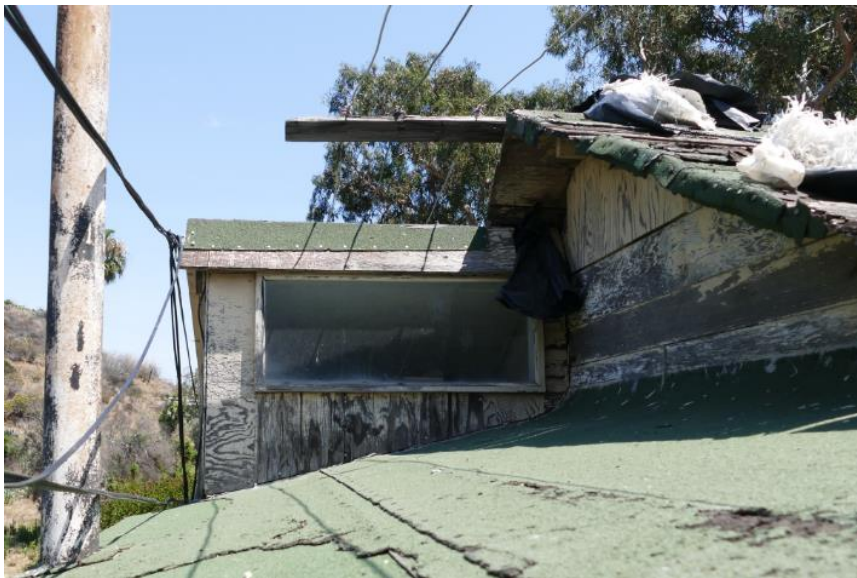
*Figure 54. Typical clerestory window found on most of the Courtyard North buildings. Photo taken facing southeast at Unit 28.*

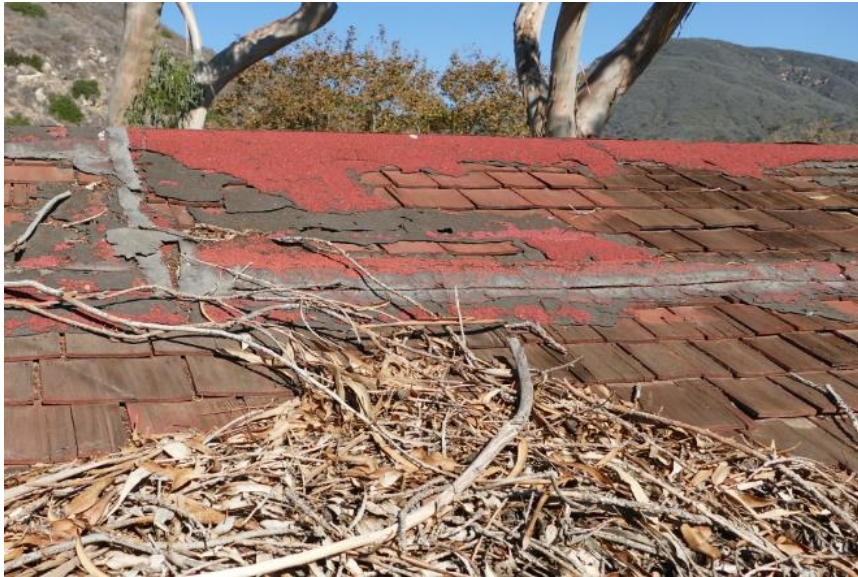
*Figure 55. Original wood shakes beneath red asphaltic sheet roofing at Unit 12. Photo taken facing north.*

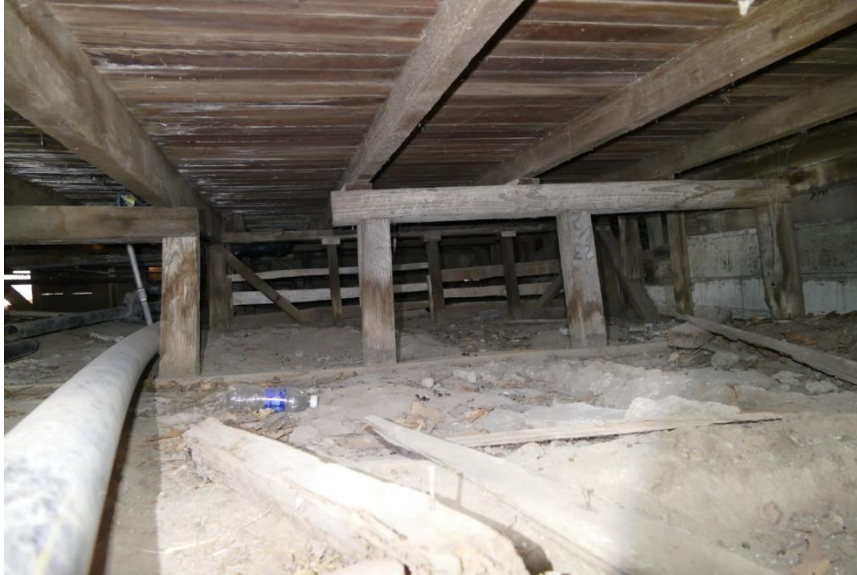
*Figure 67. Typical surface-bearing wood foundations. Photo taken facing east at Unit 2.*

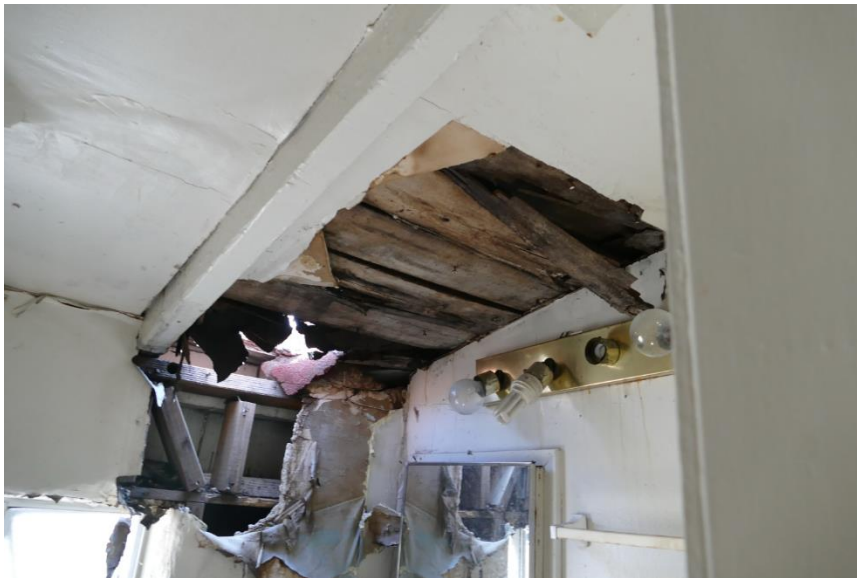
*Figure 68. Typical damage to wood framing and finishes resulting from a roof leak at Unit 8. Photo taken facing east.*

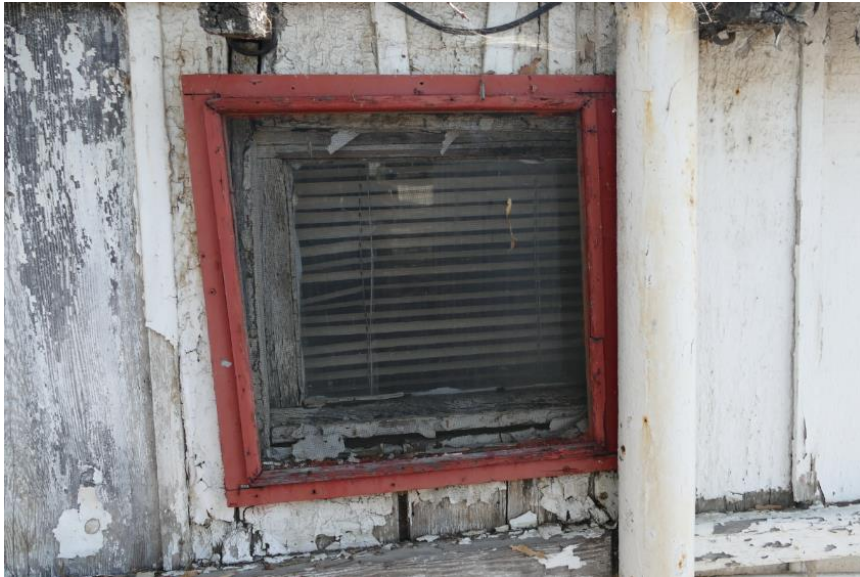
*Figure 69. Example of deteriorated wood window. Photo taken facing southeast at Unit 11.*

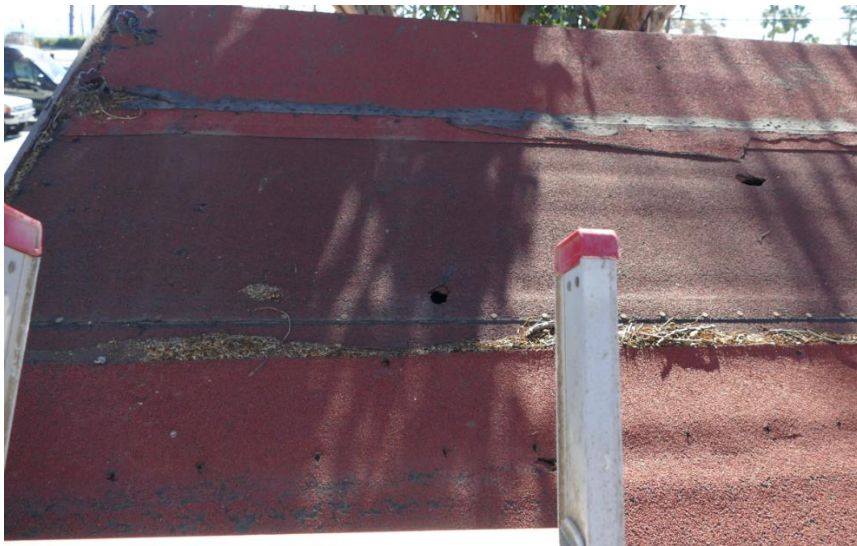
*Figure 70. Weathered roofing with open holes and tears susceptible to admitting water directly into the building at Unit 11. Photo taken facing southeast.*

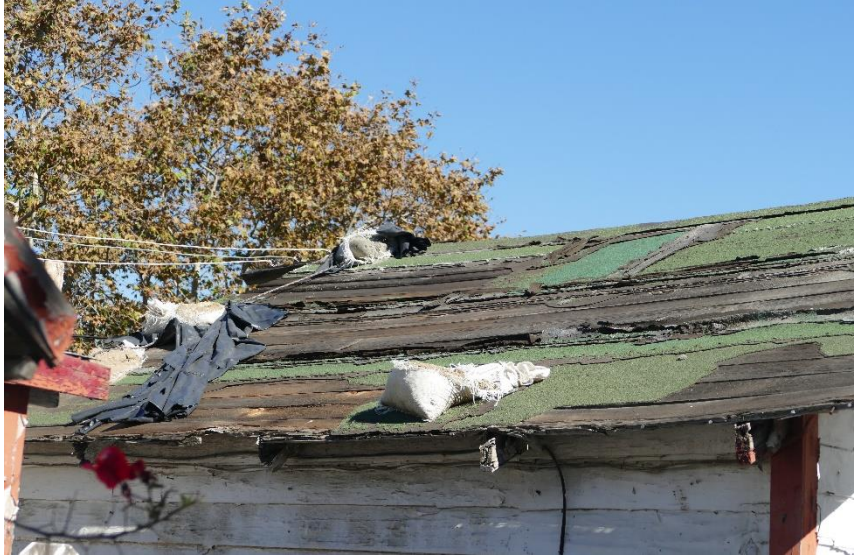
*Figure 71. Areas of exposed roof sheathing and heavily deteriorated roofing membrane on the west roof pitch of Unit 28. Photo taken facing northeast.*

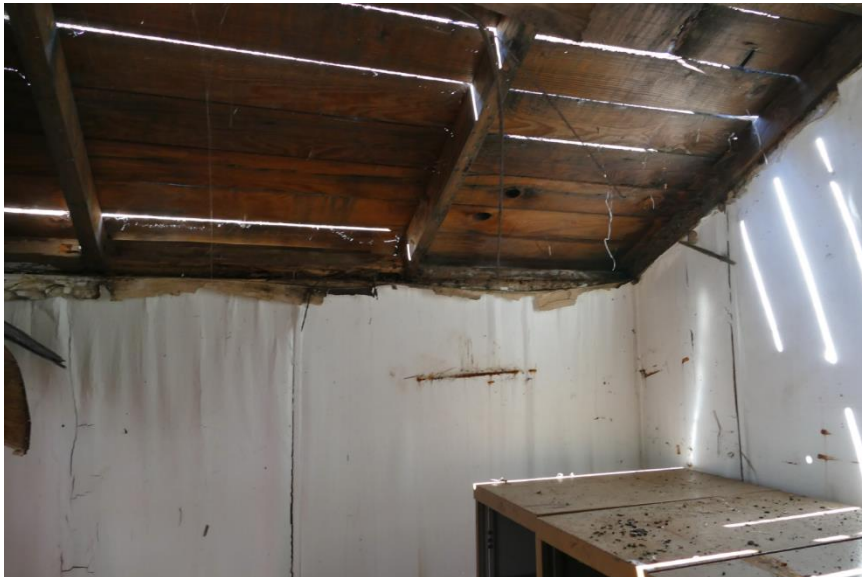
*Figure 72. Water intrusion from the exposed roof sheathing into the wall below at Unit 28. Photo taken facing northwest.*

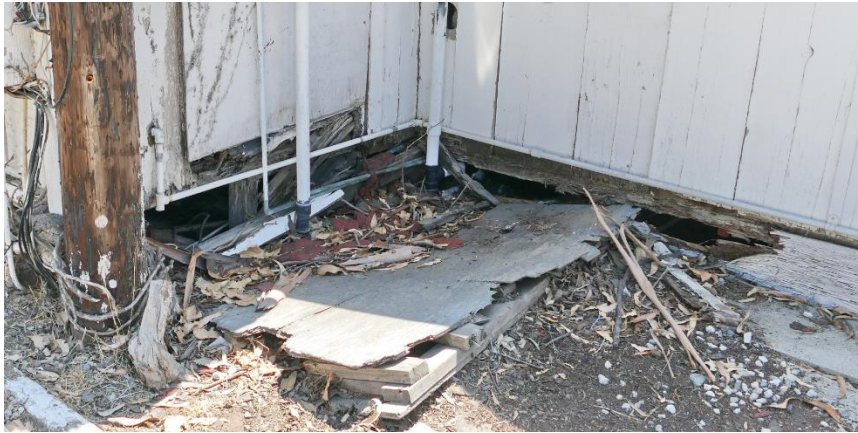
*Figure 73. Deteriorated wood cladding in proximity to soil at Units 7 and 8. Photo taken facing south.*

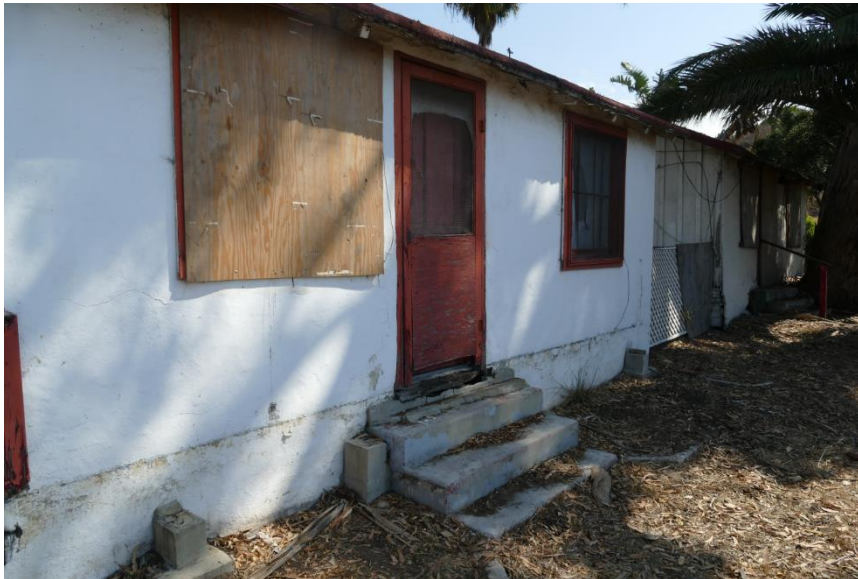
*Figure 74. Typical stucco cladding with limited cracks. Photo taken facing northeast at Unit 14.*

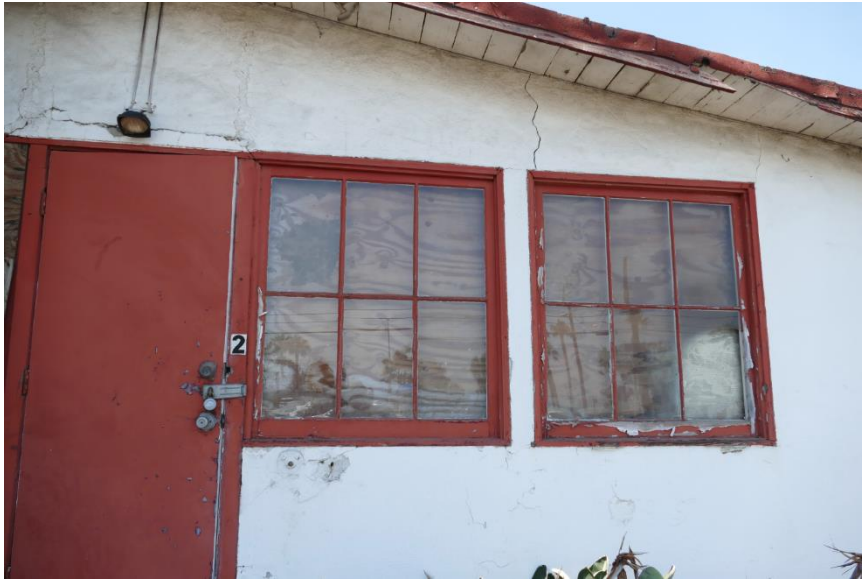
*Figure 75. Typical cracks in stucco cladding. Photo taken facing north at Unit 2.*

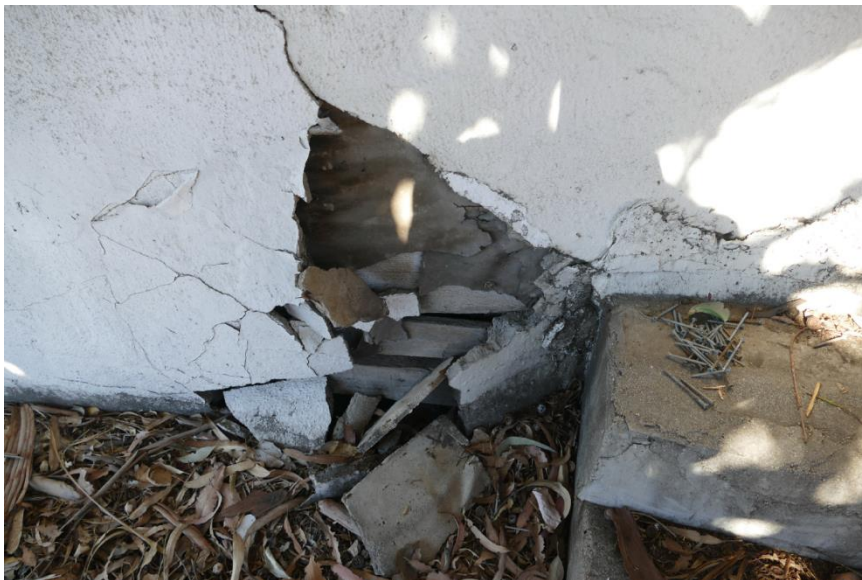
*Figure 76. Damaged stucco cladding next to the entry stairs of Unit 15. Photo taken facing northwest.*

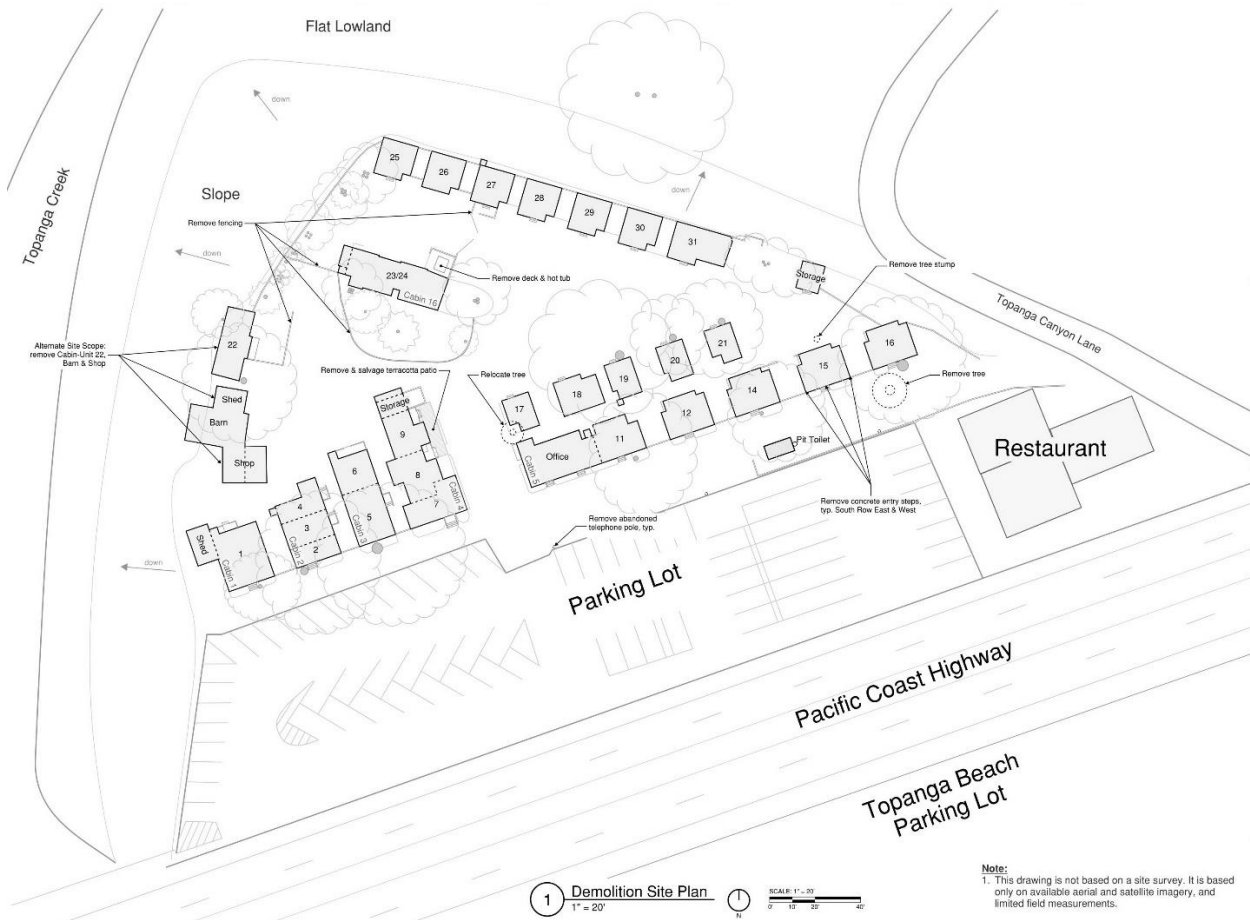
Figure 77. Demolition Site Plan of Topanga Ranch Motel.

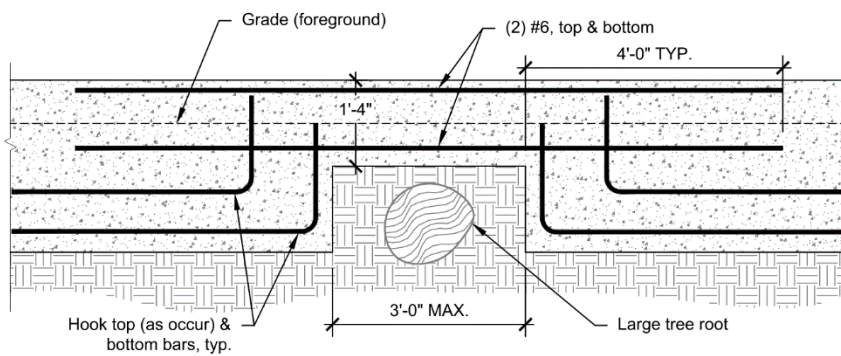
Figure 78. Conceptual "root bridge" detail where concrete foundations pass over large tree roots.

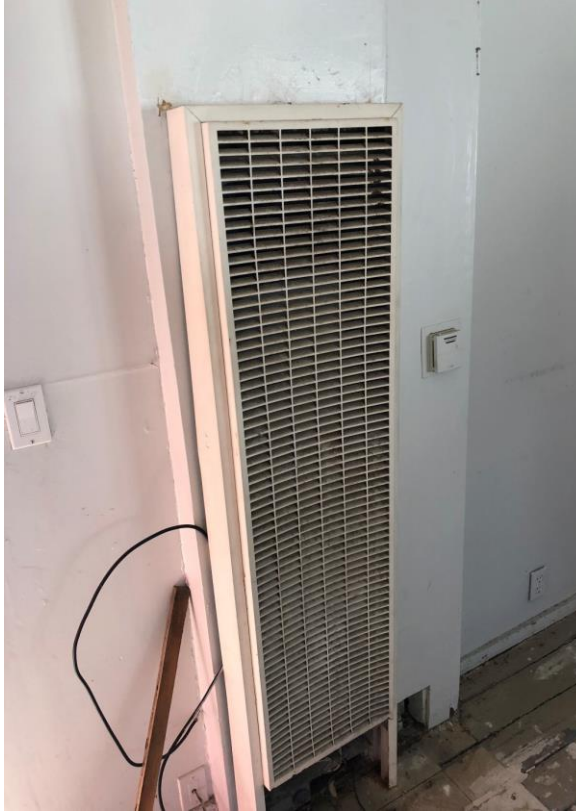
*Figure 79. Gas Furnace Interior.*

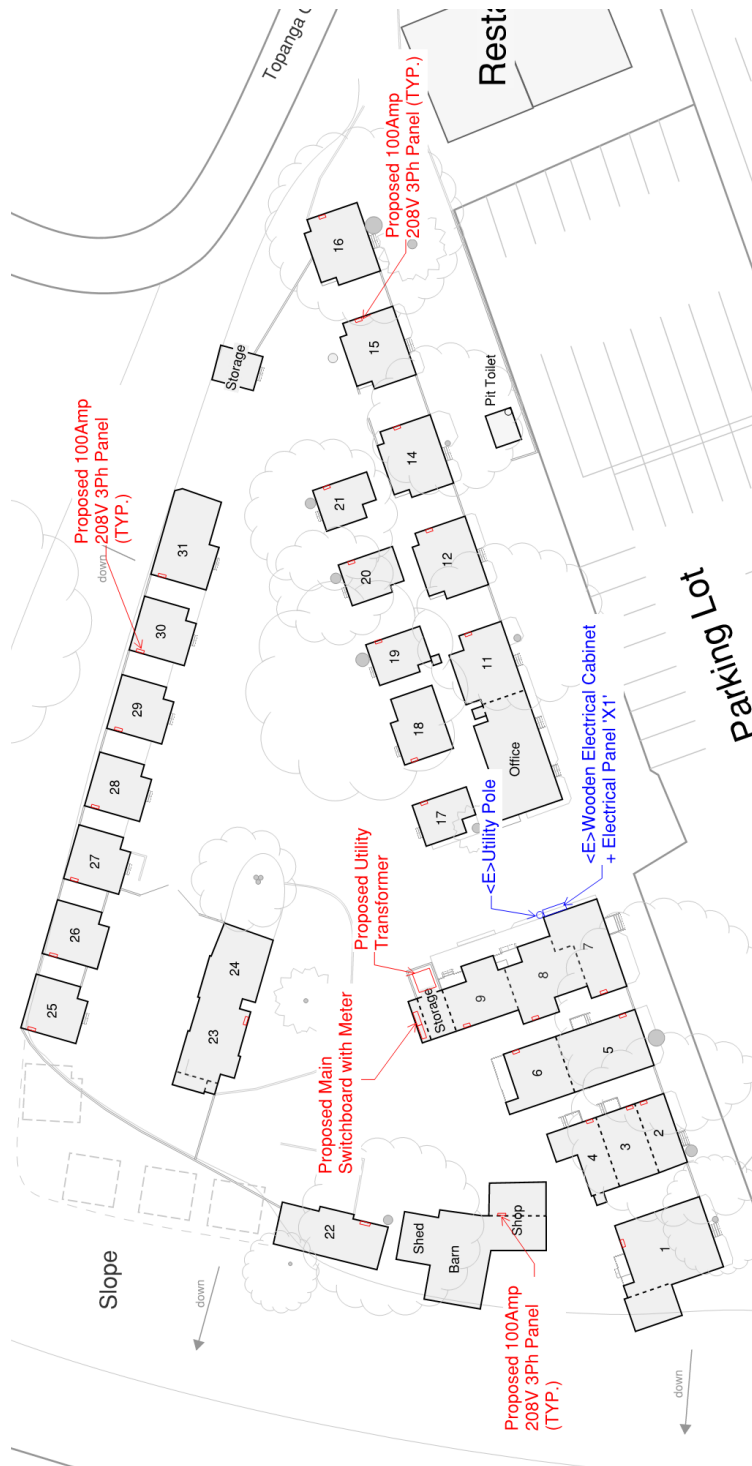
Figure 96. Proposed electrical site upgrades.

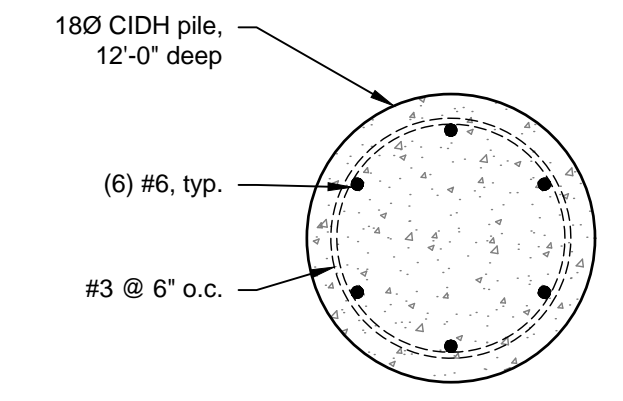
**9 Alt. Pile Foundation**  
 SCALE: 1" = 1'-0"

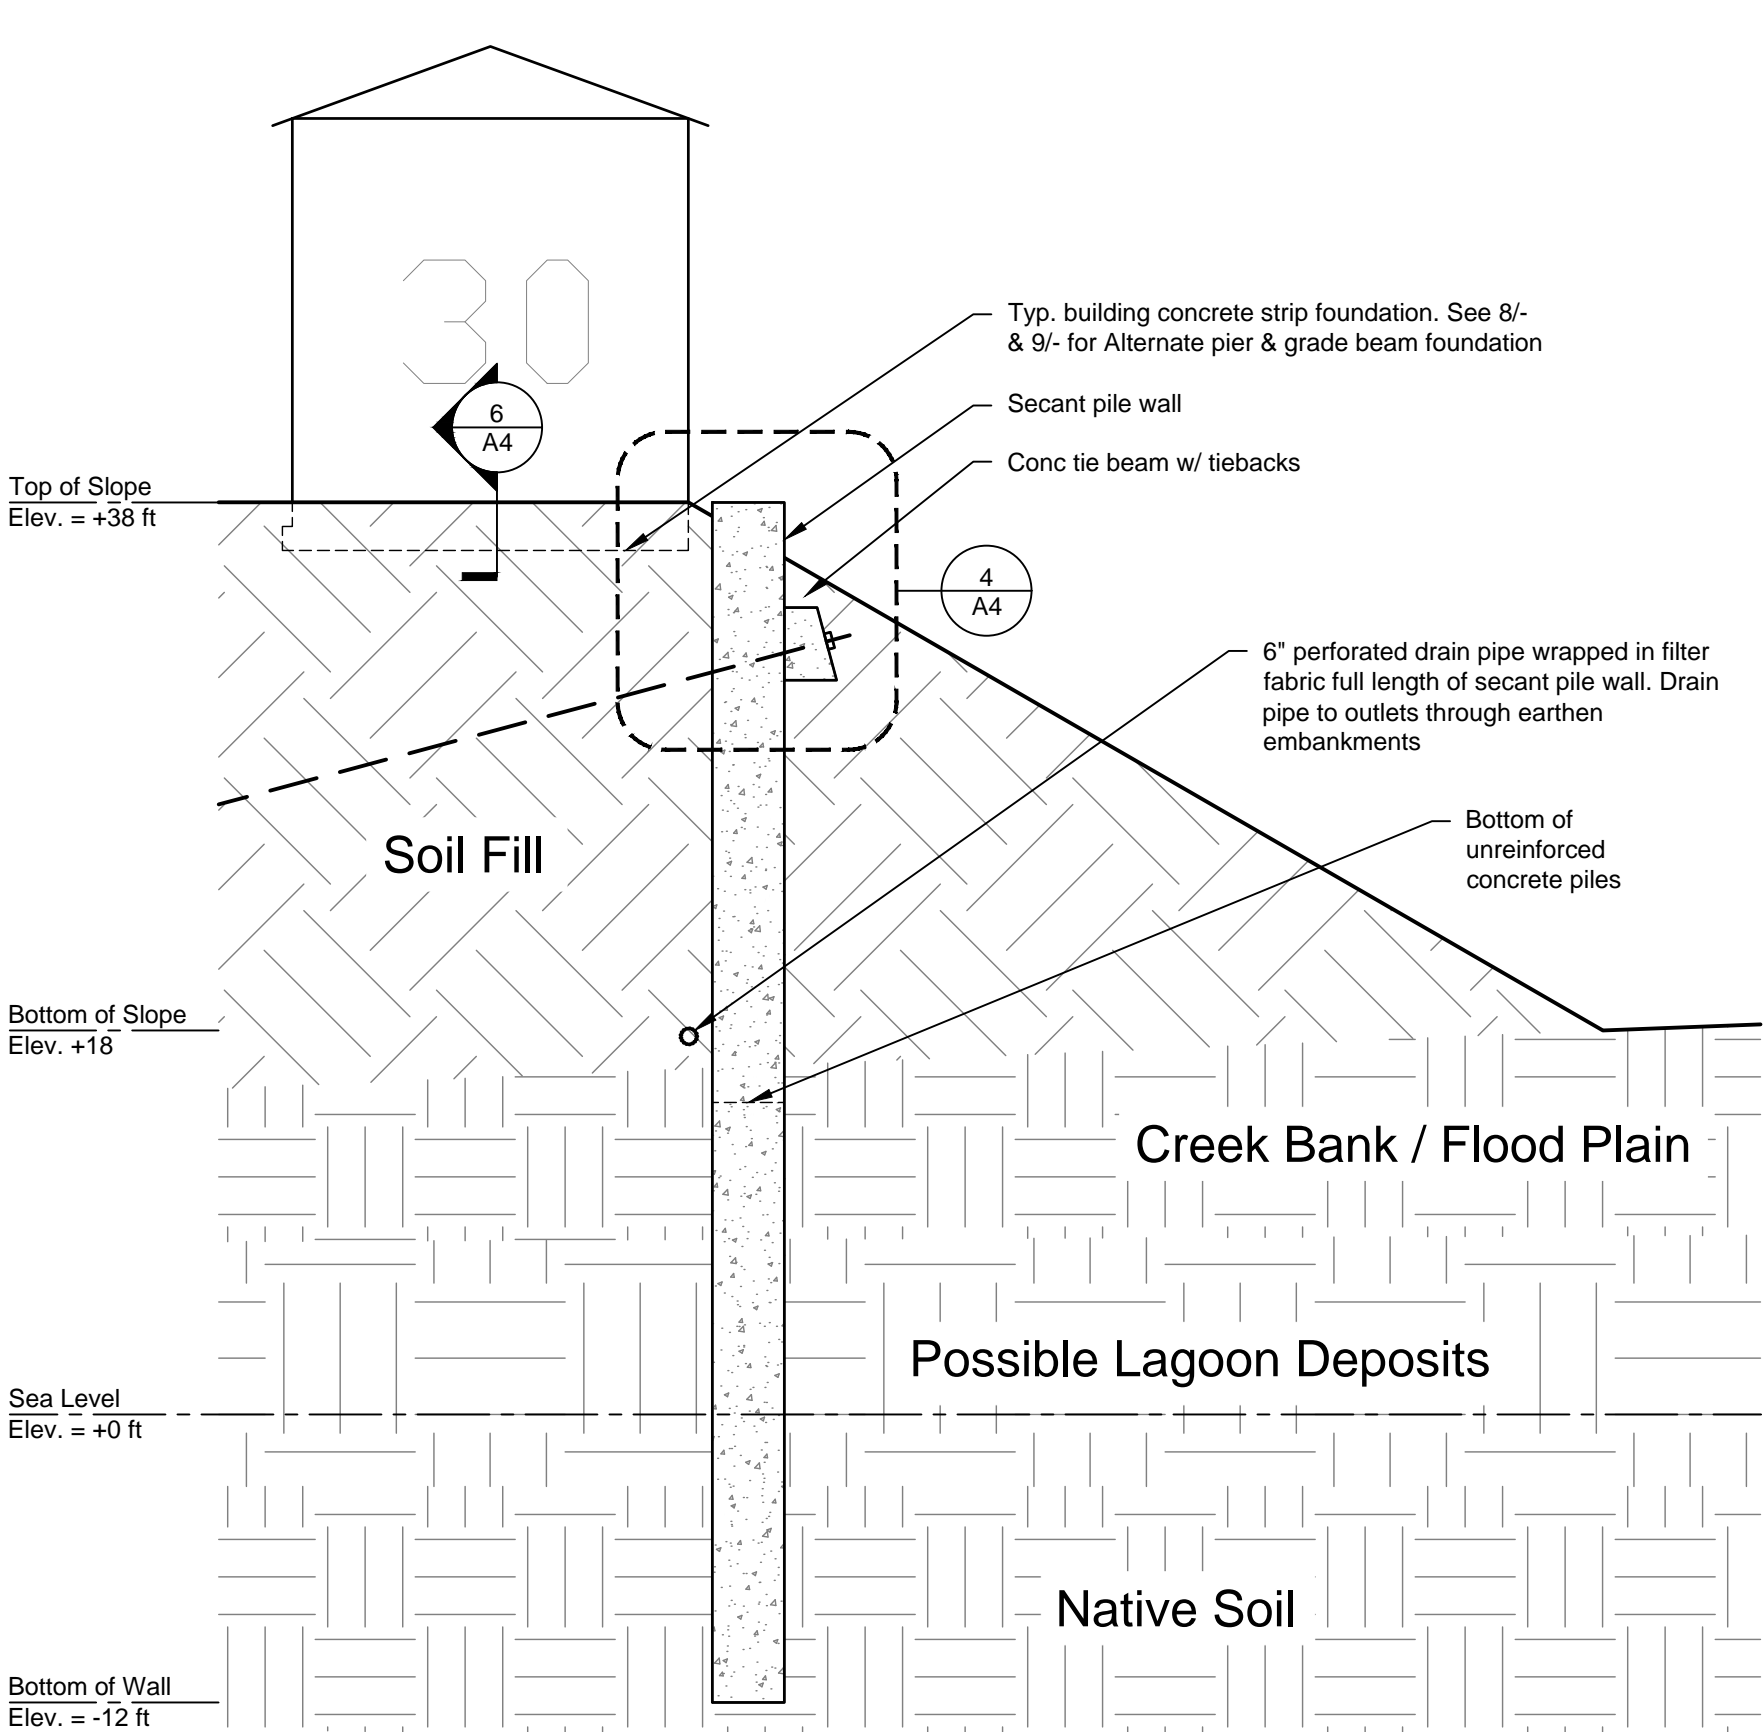
**3 Slope Section**  
 SCALE: 1/8" = 1'-0"

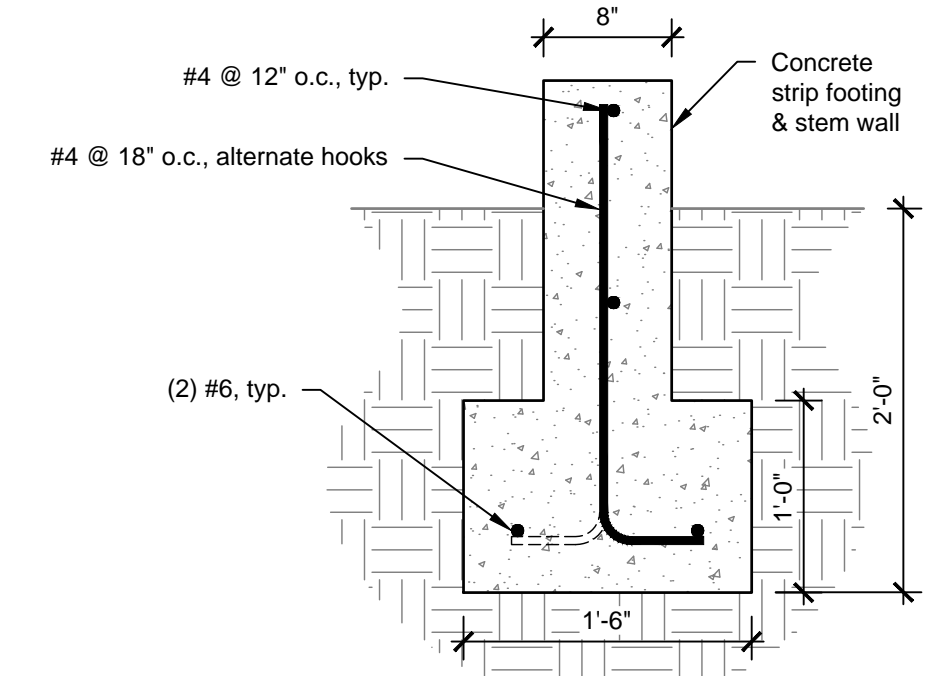
**6 Typ. Strip Foundation**  
 SCALE: 1" = 1'-0"

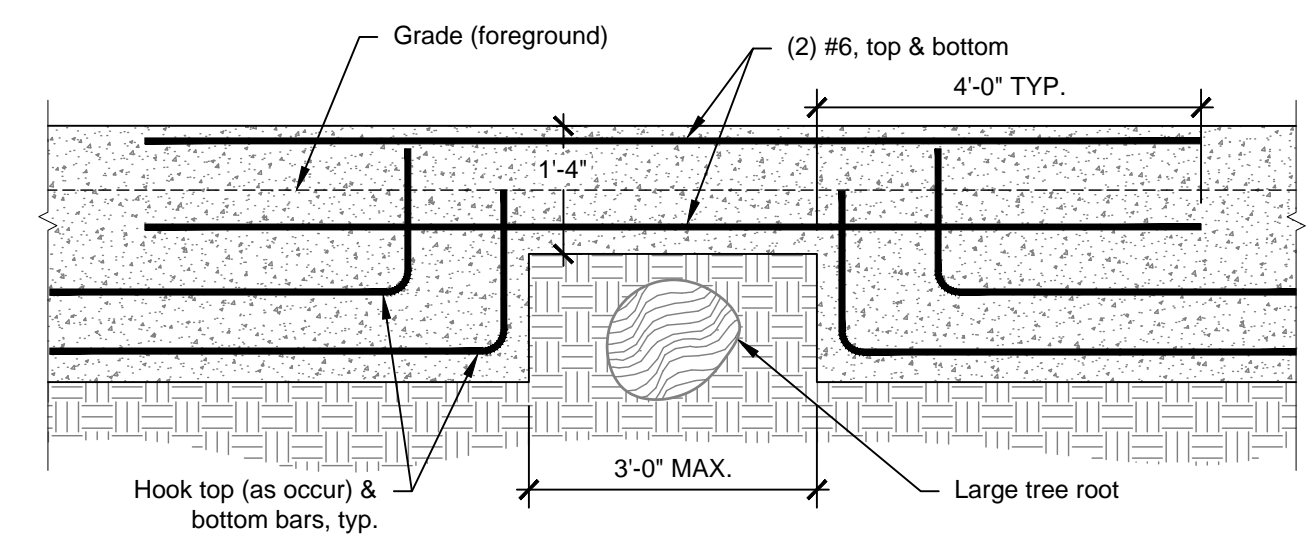
**7 Typ. Strip Foundation Root Bridge**  
 SCALE: 1/2" = 1'-0"

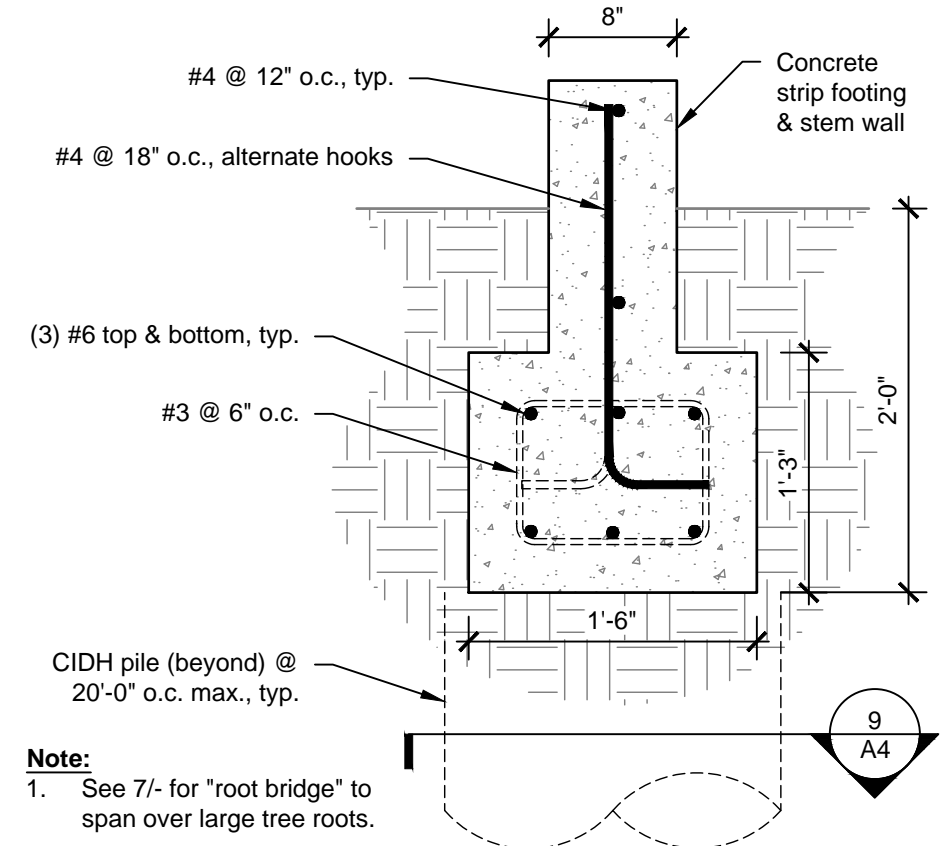
**8 Alt. Grade Beam Foundation**  
 SCALE: 1" = 1'-0"
