07-LA-27  
PM 0.0/9.0  
EA 930185

## TOPANGA ENVIRONMENTAL CORRIDOR STUDY

ON STATE ROUTE 27 IN THE COUNTY OF LOS ANGELES  
From State Route 1 (Pacific Coast Highway) to Top of Topanga

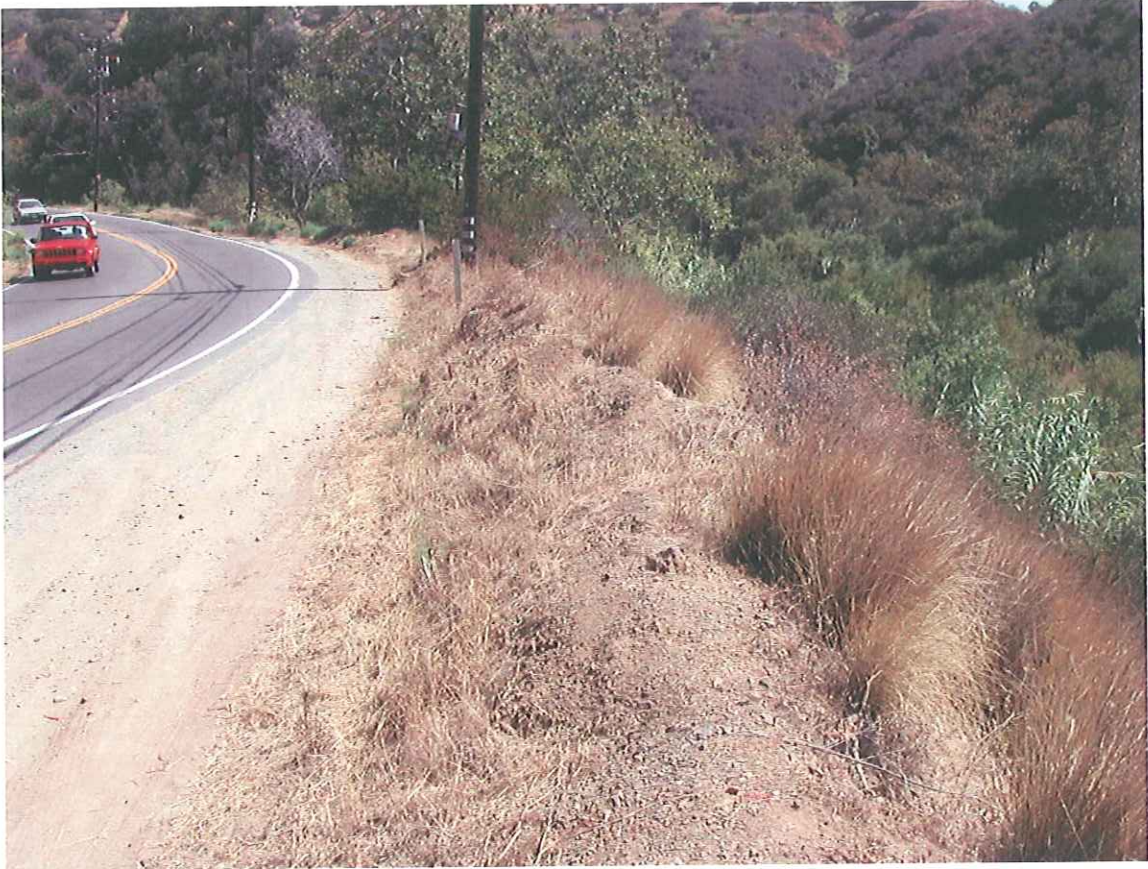
**Figure 3 – Soil Berms along SR-27 adjacent to Topanga Creek**

Roads throughout the Topanga Creek watershed also contribute to erosion and sediment yield in the creek. Soil berms are stockpiled along the side of Topanga Canyon Blvd., which can then erode directly into the adjacent creek during overland rain flows (see Figure 5). However, cut slopes that were created to install the roadway itself, have the most impact in terms of erosion in the canyon. Because the slopes were cut in order to build SR-27, they are unstable and very easily prone to erosion. During and after heavy rains, these slopes yield the most sediment flows, seepage waters, and debris that mostly end up in Topanga Creek. In addition, these cut slopes can also lead to slope failure and landslides (Dagit and Webb 2-6).

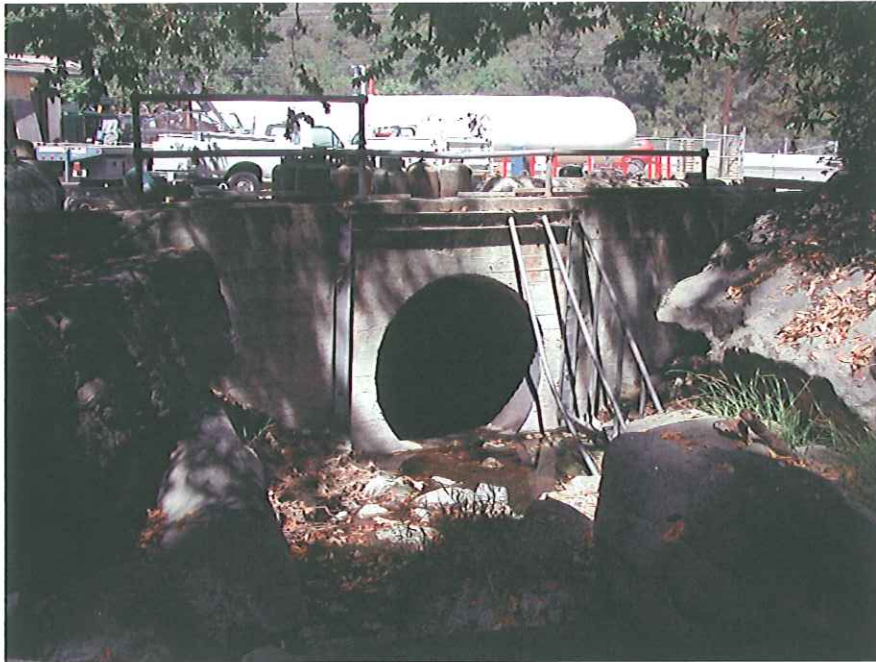
**Figure 16 – Culvert Located at PM 3.7**

The culvert at PM 3.7 does not get clogged regularly. The culvert at PM 7.2 is actually in need of cleaning; however, the responsibility of the culvert belongs to the Los Angeles County Flood Control because the inlet is located outside of Caltrans' right-of-way. For these reasons, culvert cleaning is not a regularly occurring Caltrans maintenance practice in Topanga Canyon (Cutting).

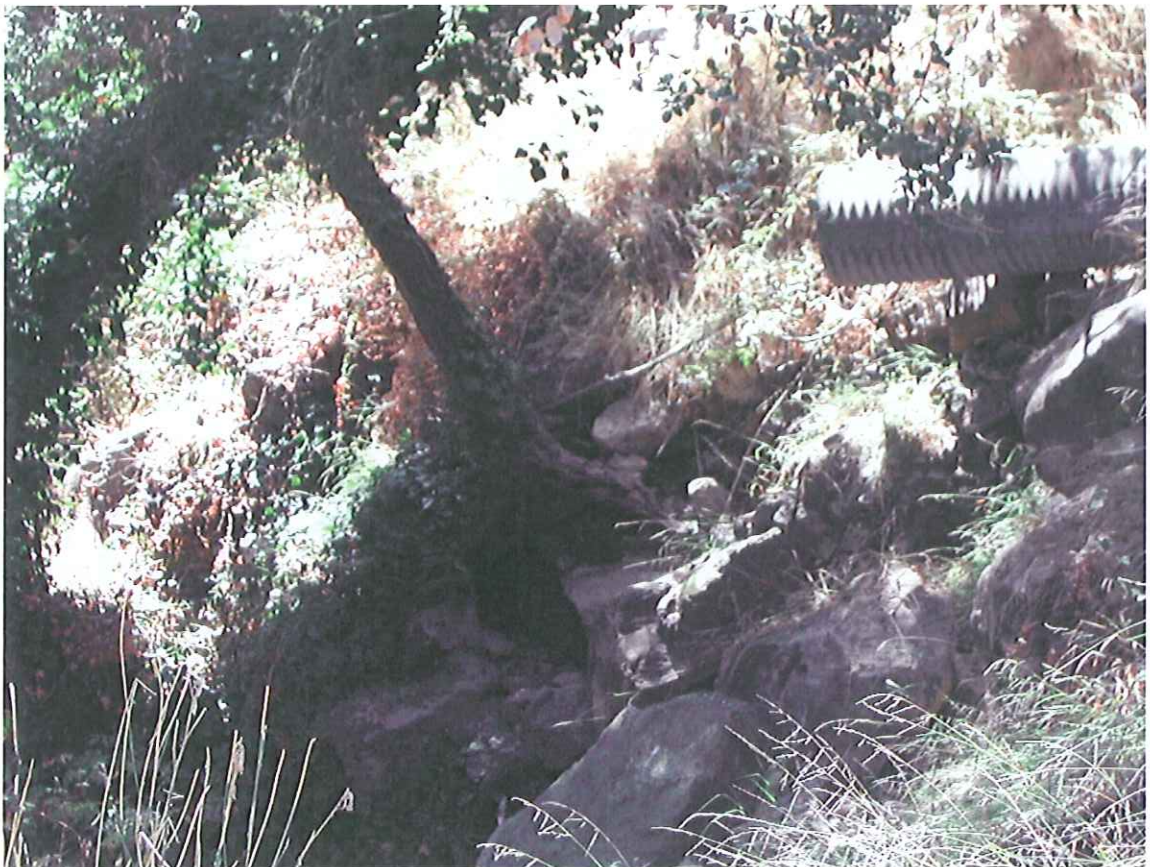
**Figure 23 – View of Culvert Causing Erosion**

Culverts act to divert water underneath the roadway into main streams. Since the water is funneled through these narrow passages, water velocity can be high. Oftentimes the culverts are emptied into the sides of streams where the water flows directly onto the streambanks. This creates erosion on the slope, affects local vegetation, and also can undermine the roadway (see Figure 25).

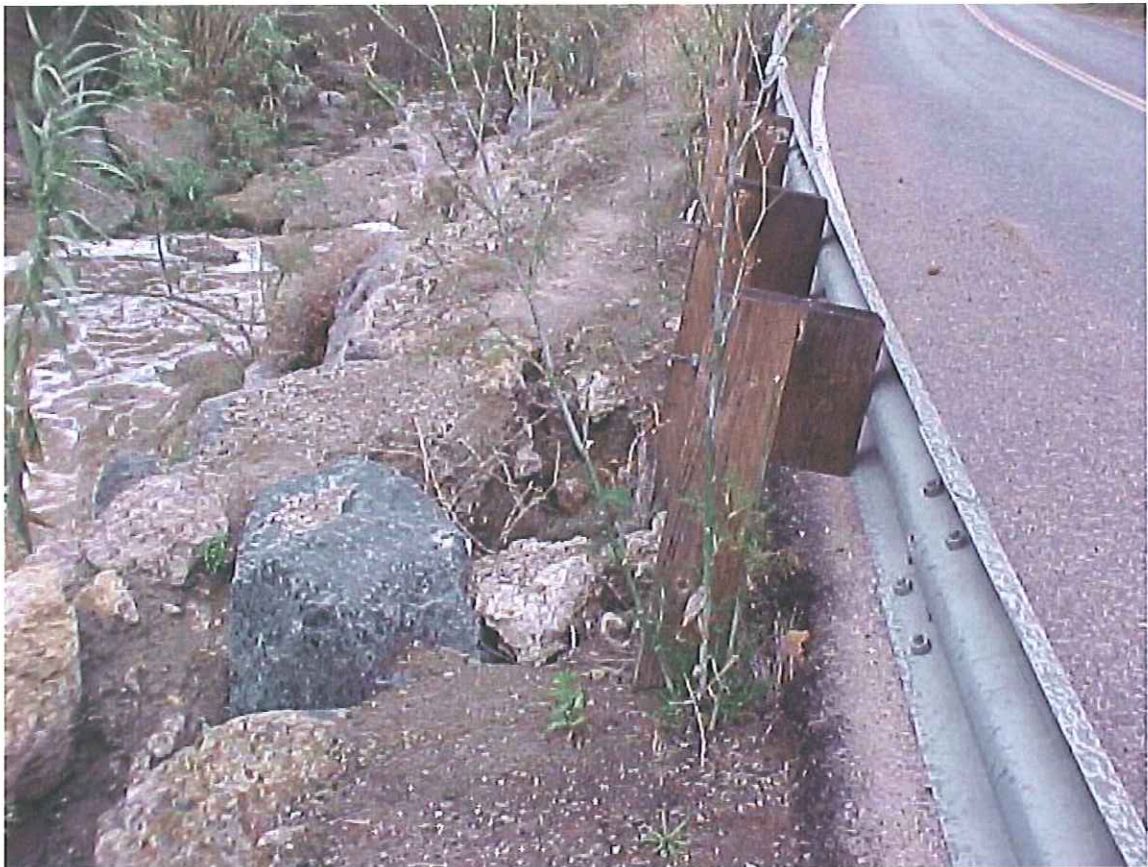
**Figure 24 – Erosion Caused by a Fill Slope on SR-27**

Cut and fill slopes in the canyon facilitate erosion of the affected soils. These slopes are not very stable because they are disturbed and part of their soil structure was destroyed. For these reasons erosion of the topsoil occurs over time. Eventually, this

erosion causes the soil to fall into the creek causing increased sedimentation (see Figure 26).

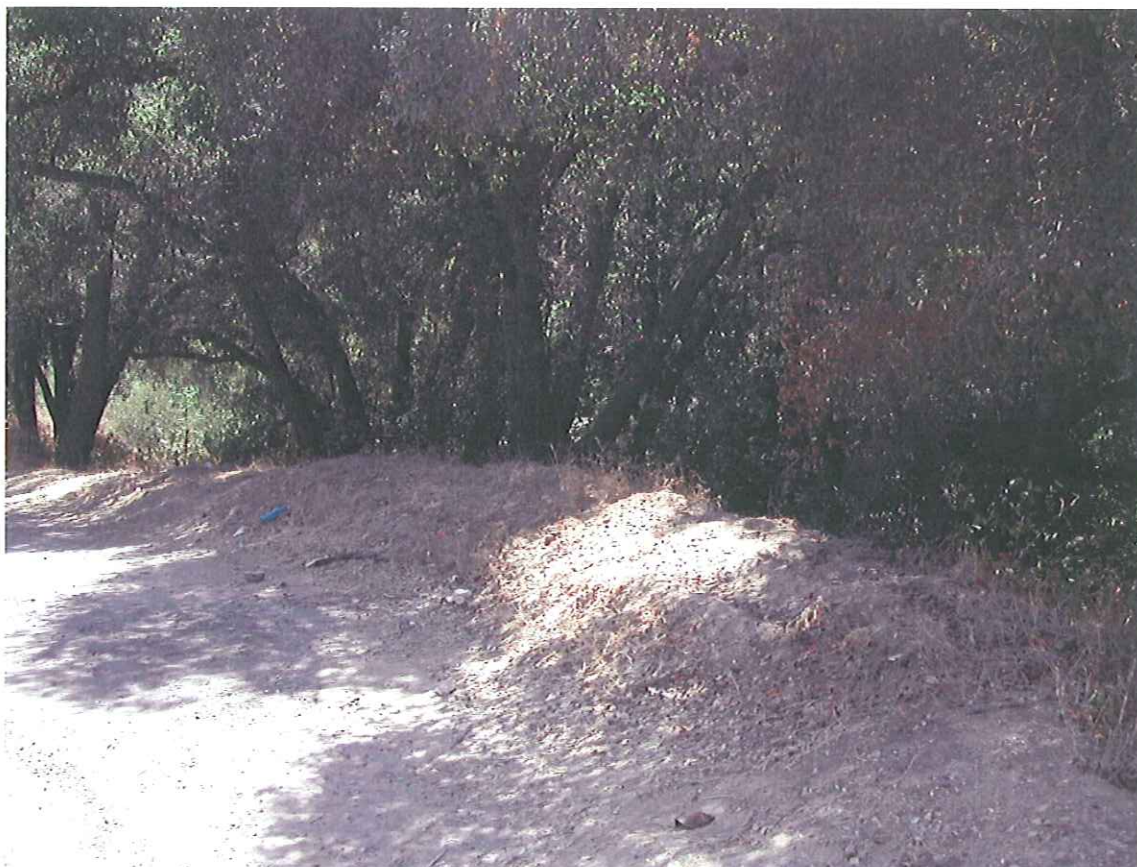
**Figure 25 – Soil Berms Impacting Oak Roots**

One of the resources that are impacted is the root system of mature native trees. Coast live oak trees (*Quercus agrifolia*) in particular are sensitive to soil berms covering their roots (see Figure 27). The soil berms smother the shallow extensive horizontal root system, which is vitally important to the overall health of the tree. This root system supplies the exchange of gases and water to the tree. If excessive berming occurs over these roots, this exchange is halted and moisture can be trapped, thus leading to root or crown rot (Johnson and Gustafson 2).

Berming of soils and other material sloughed from eroding hillslopes cause impacts to a number of resources in Topanga Canyon. Instead of berming the material, maintenance crews should locate and use a proper disposal site in the canyon to dump

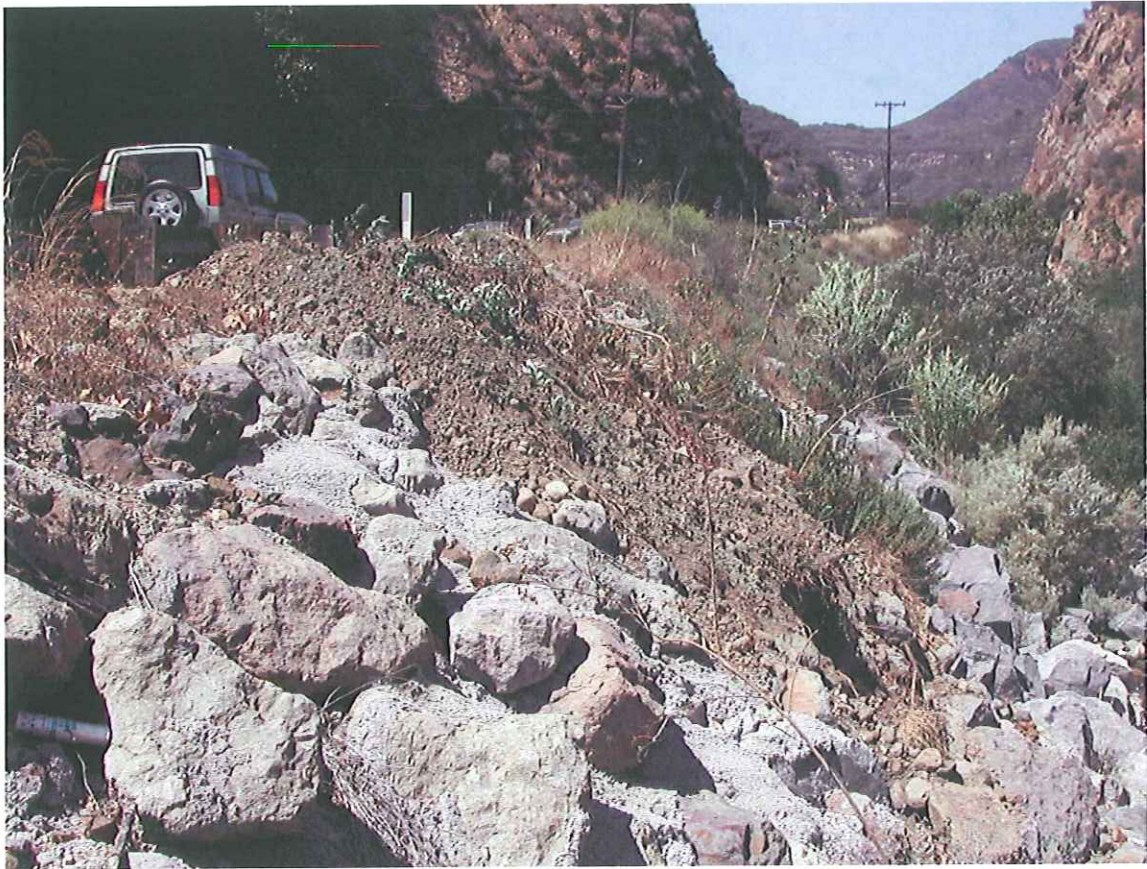
**Figure 26 – Soil Berms Sloughing into Creek**

Another problem associated with soil berming on the side of the highway is the spillage of excessive material into the adjacent creek. This sedimentation occurs when the berms are placed at the top of the slope supporting SR-27, which is located next to Topanga Creek or one of its tributaries (see Figure 28). Gradually, soil becomes displaced from the berm and slides down into the creek. Sedimentation into the creek can contribute to decreased water quality and degraded aquatic habitat.

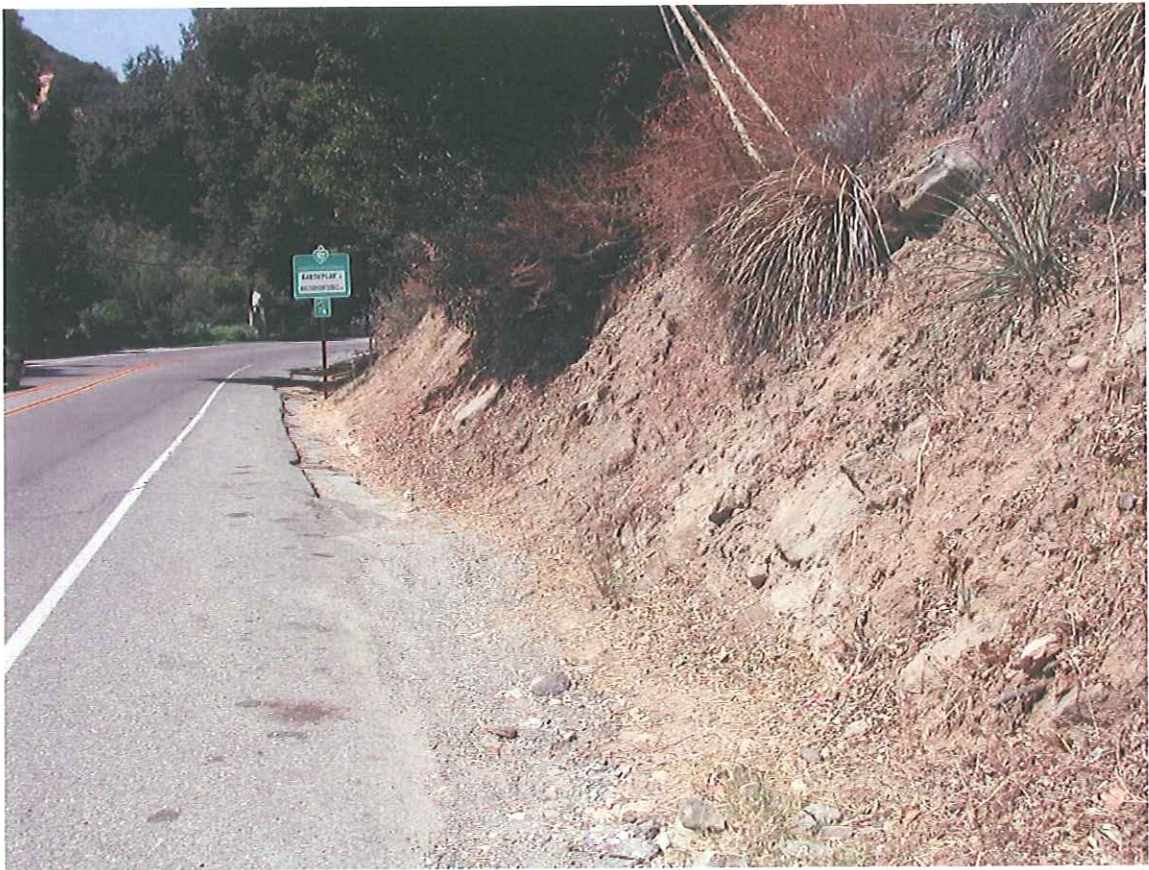
Figure 27 – Slope Mowing along SR-27

Slope mowing also prevents the existence of sensitive native plants that are ecologically adapted to rocky slopes, such as the Santa Monica dudleya (*Dudleya cymosa* ssp. *Ovatifolia*) and Santa Susana tarweed (*Hemizonia minthornii*), which are found in Topanga Canyon. The continued disturbance of the slopes decreases the overall habitat for these and many other native species to thrive. Therefore, the presence of sensitive species within the zone of slope mowing is extremely rare.

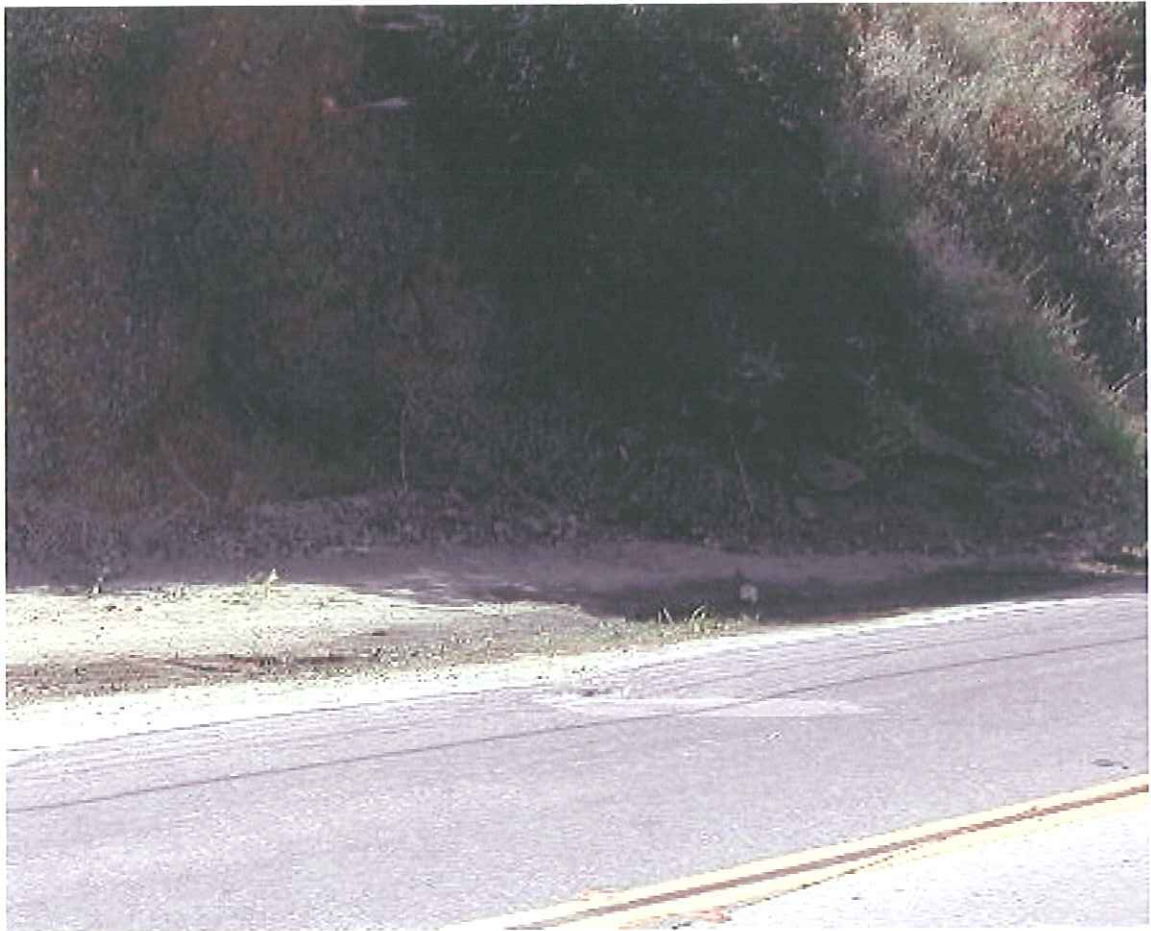
**Figure 30 – Same Wetlands at PM 2.2 after Shoulder Mowing**

Vegetation mowing performed by maintenance crews also involves the mowing of shoulders next to the highway, called “shoulder mowing”. Shoulder mowing on a regular basis increases the presence of invasive exotic species that can out-compete natives (see Figure 30). Shoulder mowing also degrades aquatic habitat that exists adjacent to the side of the highway in certain locations (see Figure 31). These locations have become established due to natural ground springs emitted from the canyon faces. Amphibians routinely use these seeps to spawn, and numerous tadpoles are found at these locations every year. When shoulder mowing occurs here, the aquatic organisms and

their habitat are destroyed due to heavy equipment traffic and vegetation removal (see Figure 32).

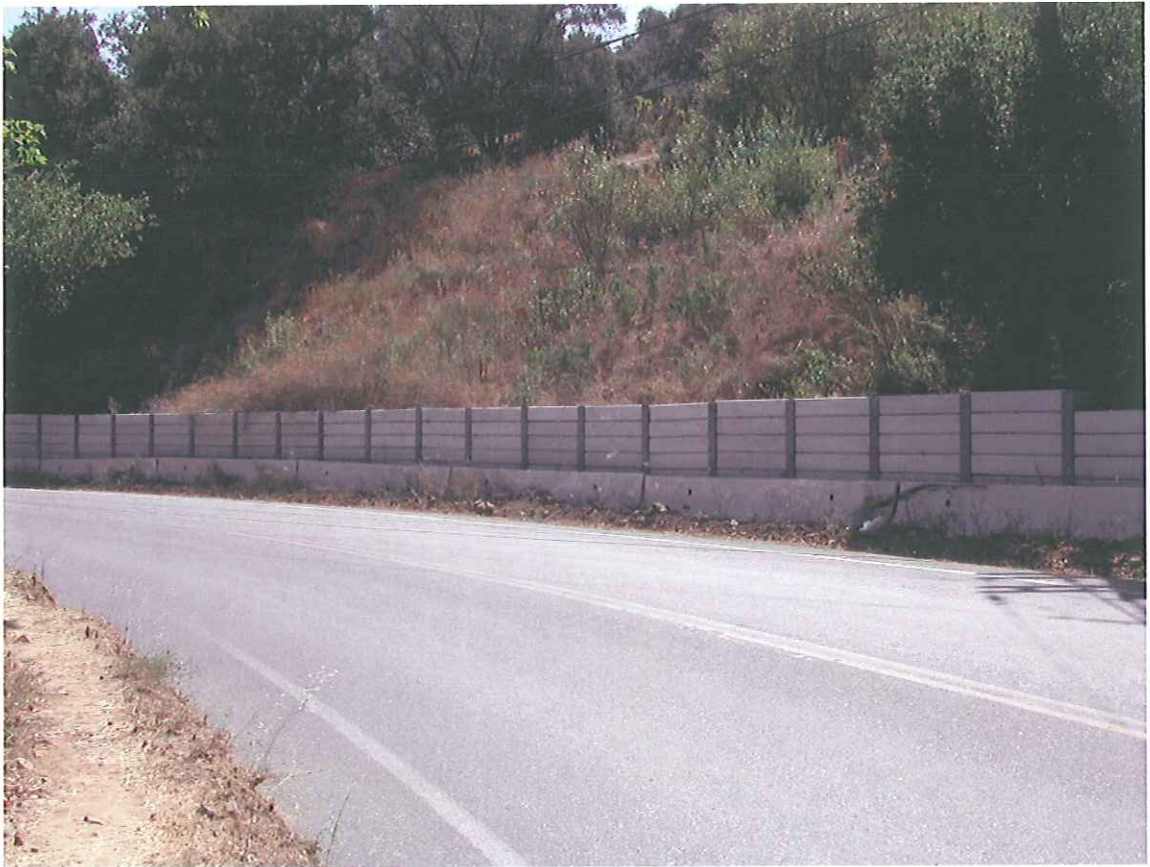
**Figure 31 – Concrete Retaining Wall at PM 5.45**

The introduction of retaining walls in the canyon is typically implemented to support slopes from failing. It is generally considered a safe engineering solution to protect structures and roads. Usually retaining walls are designed and constructed as part of planned construction activities in an area, although maintenance crews can also be involved in their construction. One particular retaining wall in Topanga Canyon was constructed as part of maintenance efforts to protect the roadway from a potential landslide. The slope was becoming destabilized and therefore a retaining wall was constructed to prevent the failure (see Figure 33). The problem with this retaining wall is that it is not aesthetically appealing. The white façade does not blend with the natural coastal sage scrub hillside it is protecting. Also, this wall is constructed on a curve and therefore is visible from a distance away. Again, the natural beauty of the canyon suffers from the construction of a hardscape element.

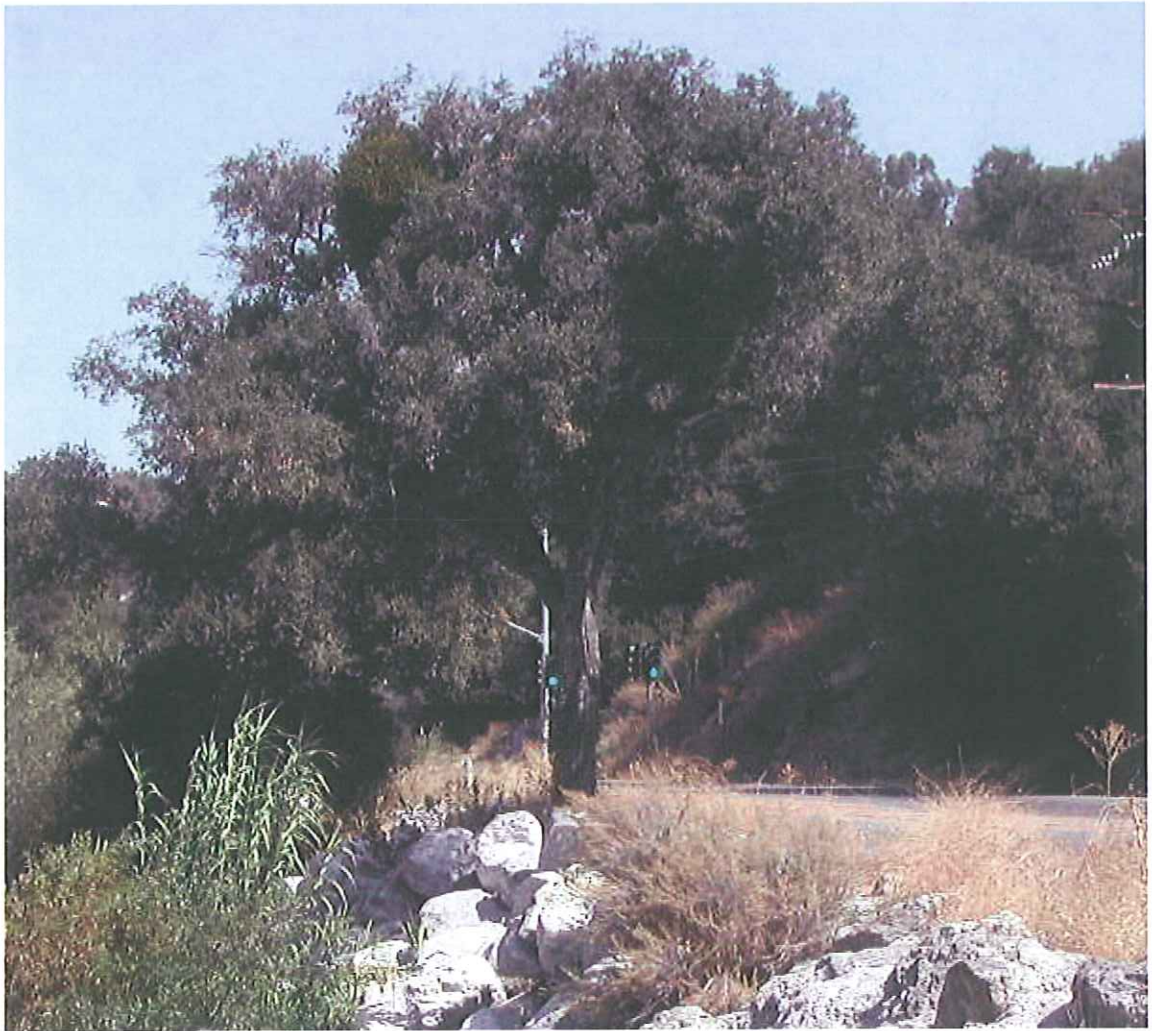
**Figure 32 – Riprap Placed at Base of Oak Tree**

A type of native vegetation that is impacted with the installation of RSP is the coast live oak. If RSP, especially grouted, is placed around an existing oak, the root system can become compromised, much like soil berming (see Figure 34). The survival of coast live oaks surrounded by grouted RSP is not likely.

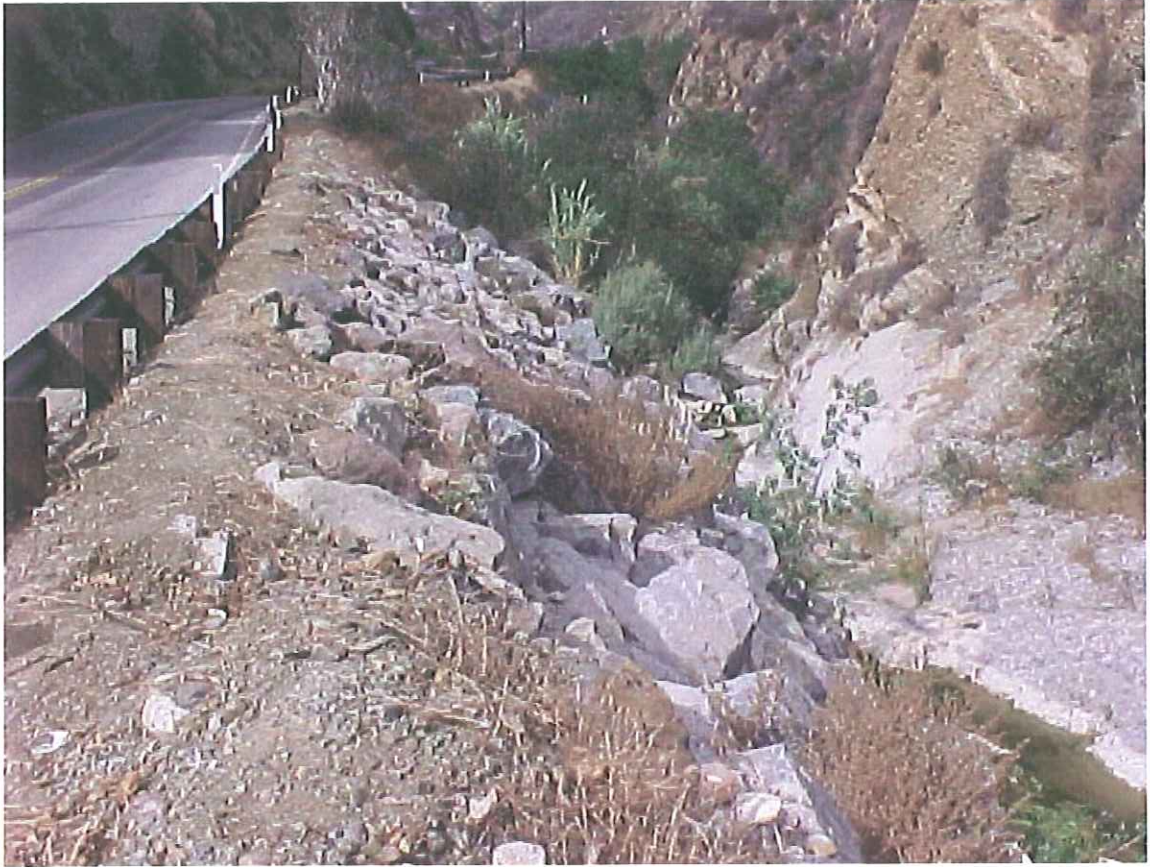
**Figure 33 – Riprap on Slope adjacent to Steelhead Trout Location**

The installation of RSP on the banks of the stream channel destroys the natural vegetation growing on the slope. This vegetation provides habitat for various organisms and also shelters the stream and cools the water. Various species found in or near Topanga Creek are sensitive including the steelhead trout (*Onchorhynchus mykiss*), California newts (*Taricha torosa torosa*), western pond turtle (*Clemmys marmorata*), San Diego mountain kingsnake (*Lampropeltis zonata pulchra*), and the two-striped garter snake (*Thamnophis hammondi*). The installation of this element would therefore eliminate all of these natural resources that may exist in the affected location, including any sensitive ones. In fact, RSP was placed along the bank of Topanga Creek following a massive flood event exactly where steelhead trout now inhabit (see Figure 35). Fortunately, the fish were not present when the RSP was placed, but future flooding events and continued maintenance of this particular slope may result in harm to the species.

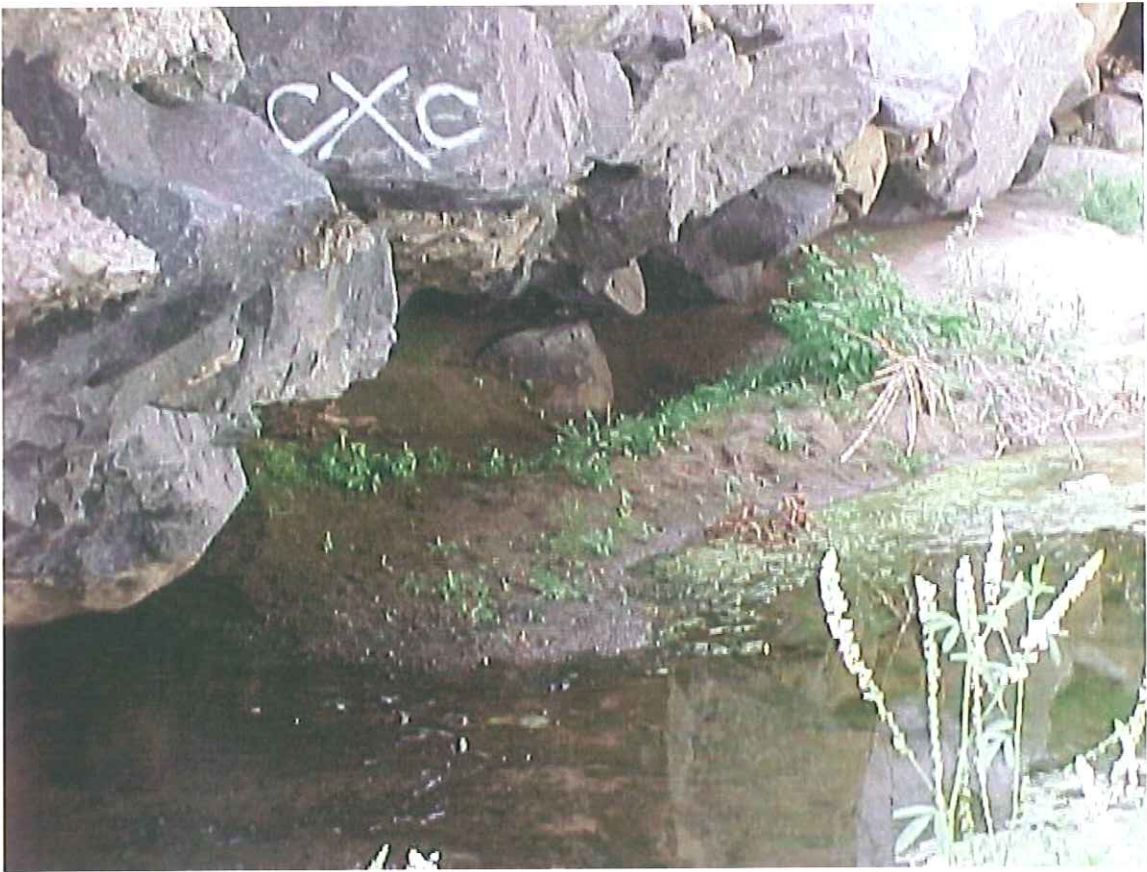
Figure 34 – Undercutting of Riprap near Steelhead Location

Rock slope protection's purpose is to secure the roadway from further erosion. Unfortunately, with high stormwater events common in Topanga Canyon the RSP is no match for Mother Nature. The RSP is clearly being undercut by the creek's strength and is therefore susceptible to failure once again (see Figure 36). In fact, various boulders have already pried themselves loose of the bank and have landed squarely in the creek, which increases the amount of unnatural debris in an already constricted stream (see Figure 37). And, if failure of the slope happens to occur during a high velocity storm event, the result would be disastrous for the aquatic organisms in the stream at that time as the boulders would become dislodged and fall directly into the creek.
