TOPANGA CREEK

WATERSHED & LAGOON RESTORATION FEASIBILITY STUDY

FINAL REPORT
TOPANGA CREEK WATERSHED AND
LAGOON RESTORATION
FEASIBILITY STUDY

April 29, 2002

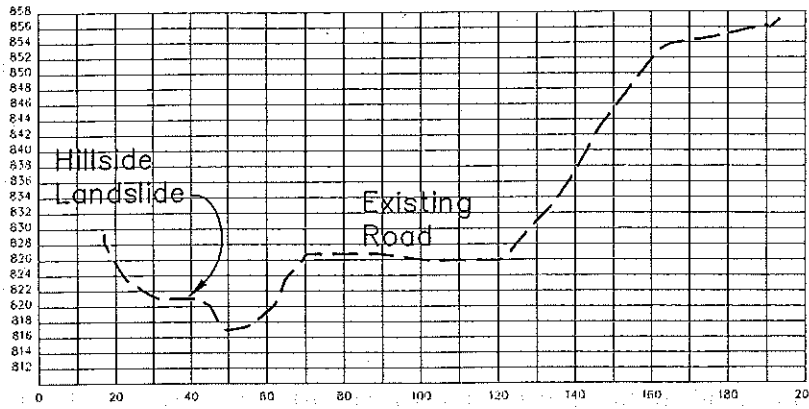
Proposed solution: The landslide is impinging significantly into the floodway of the creek. The creek cross-section is constricted to only a portion of its initial area. The landslide deposit should be cleared entirely from the creek floodway to restore it to its former cross-sectional area prior to the landslide. The landslide should concurrently be stabilized as required to prevent further sliding, and any future landslide deposits should be cleared from the floodway immediately. Figure 3-2 shows existing and proposed conditions. This will significantly improve public safety by reducing flood hazard in this section of Topanga Canyon Blvd.

Existing
Cross-Section
Horiz. Scale: 1'=50'
Vert. Scale: 1"=25'

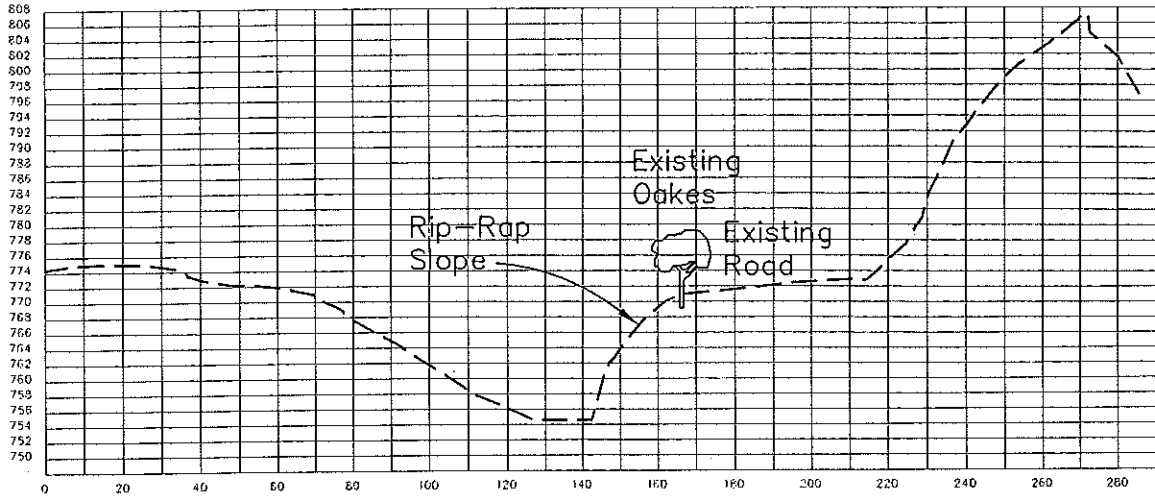
This solution will improve public safety by correcting the existing threat of flooding and undermining of the stability of Topanga Canyon Blvd. and the bridge under Topanga School Road.

Existing
Cross-Section
 Horiz. Scale: 1'=50'
 Vert. Scale: 1"=25'
