Topanga Creek Watershed Water Quality Study Final Report

October 2003-2004

December 2004

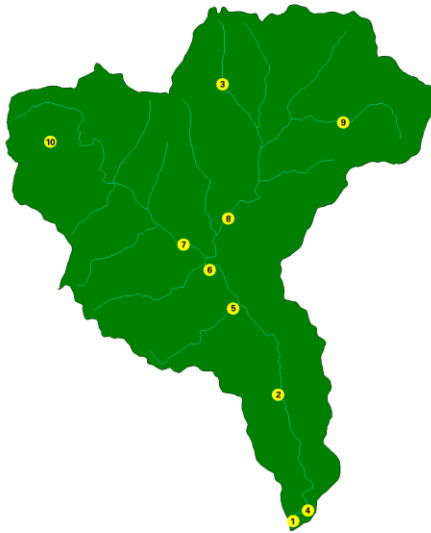
Topanga Creek Water Quality Sampling Sites 2003-2004

From October 2003 - 2004, ten sites were monitored monthly, with three of those sites monitored weekly. Sites were selected to capture representative areas of the upper watershed, as well as be accessible, and located on public lands. Several locations were monitored based on results of the Topanga Creek Water Quality Study Final Report 1999-2001 (Dagit, 2001), which indicated that these locations were experiencing higher than targeted levels of nutrients, and frequently exceeded water quality objective targets for total coliform, fecal coliform and *E. coli* bacterias.

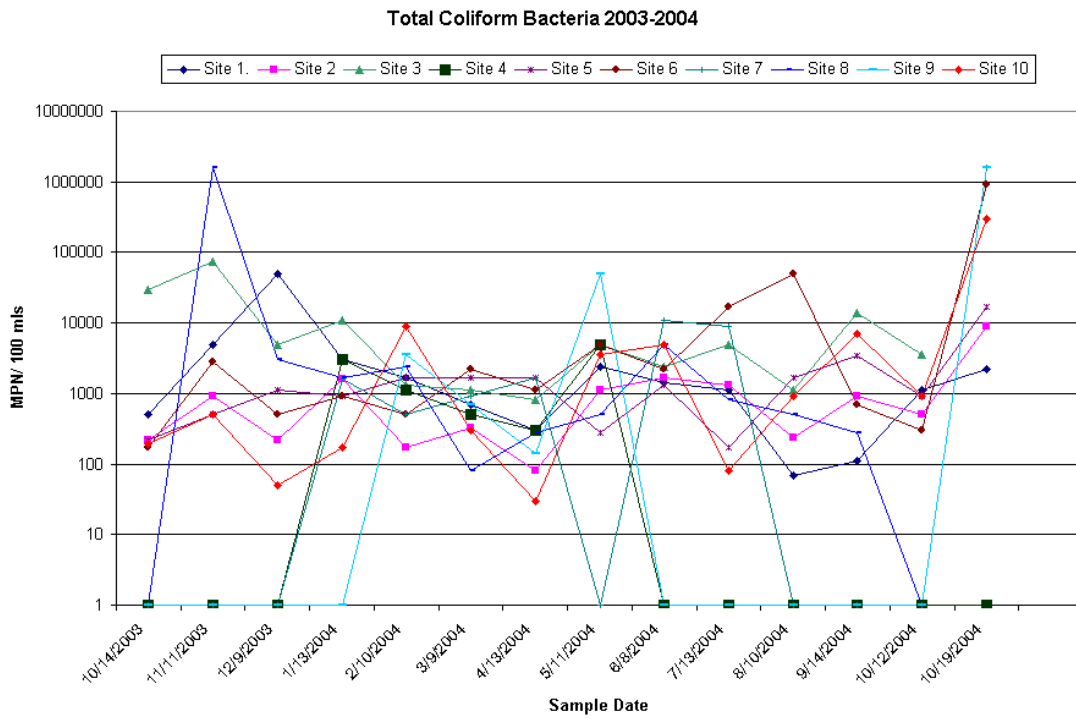
Figure 5. Total Coliform Bacteria from all Topanga Creek Watershed Sites, 2003-04

Total and fecal coliform bacteria counts documented during this study are high overall, and exceeded standards in both in wet and dry conditions, as summarized in Table 1. Site 1 Topanga Lagoon had 71% total coliform, 43% fecal coliform and 71% enterococcus exceedences. Bacteria levels at Site 2. Bridge (located mid-way between the town of Topanga and Topanga Beach) never exceeded the standard for total coliform, and only exceeded that for fecal coliform (21%) and enterococcus (50%) during rain events.

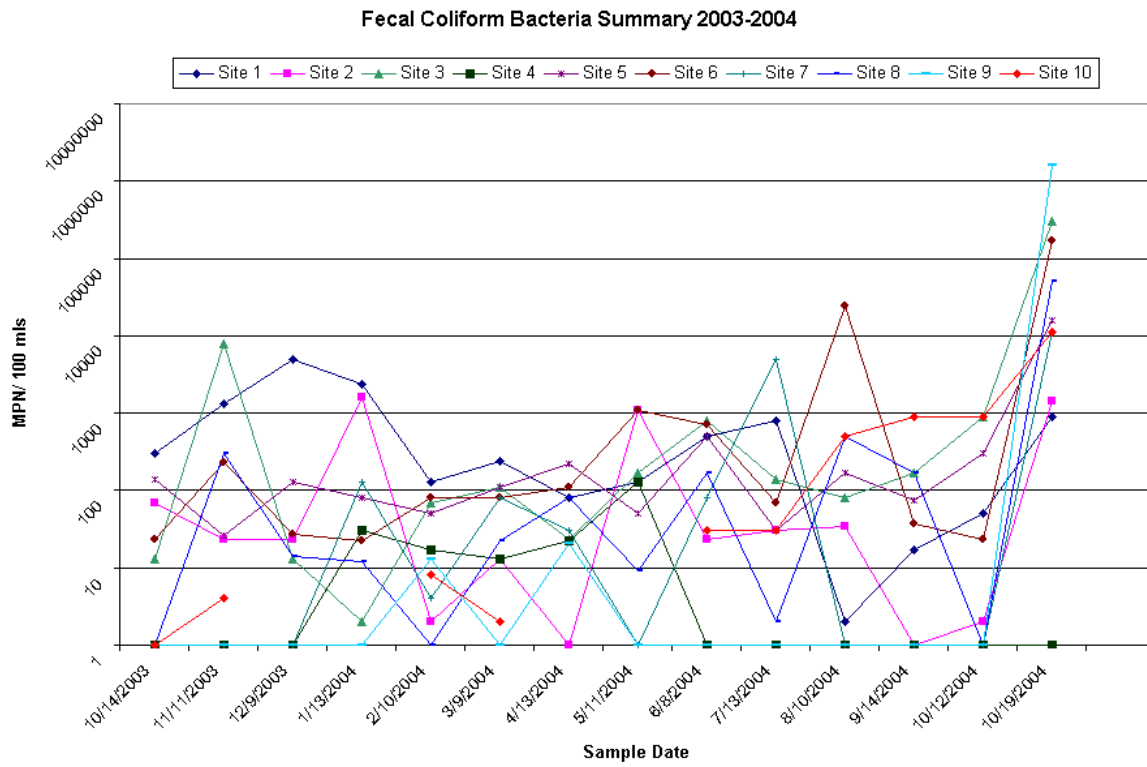
Figure 6. Fecal Coliform Bacteria from all Topanga Creek Watershed Sites, 2003-04

Fecal coliform bacteria originate in the guts of mammals and birds. Therefore, presence of these bacteria is a good indicator of contamination from sewage, septic systems, greywater systems, wild populations of birds and mammals, domestic and corralled animals. While these bacteria are not necessarily pathogenic, they are readily measured, and have become the standard for evaluating the role of fecal contamination in receiving waters. Fecal coliform contamination has also been associated with impacts to nearshore shellfish. Studies used by the EPA to evaluate different indicator bacteria found that levels of fecal coliform were not as reliable in predicting rates of illness in swimmers as enterococcus (EPA 1986). However, standards for beach closure are still using fecal coliform limits of 400 MPN/ 100 ml.

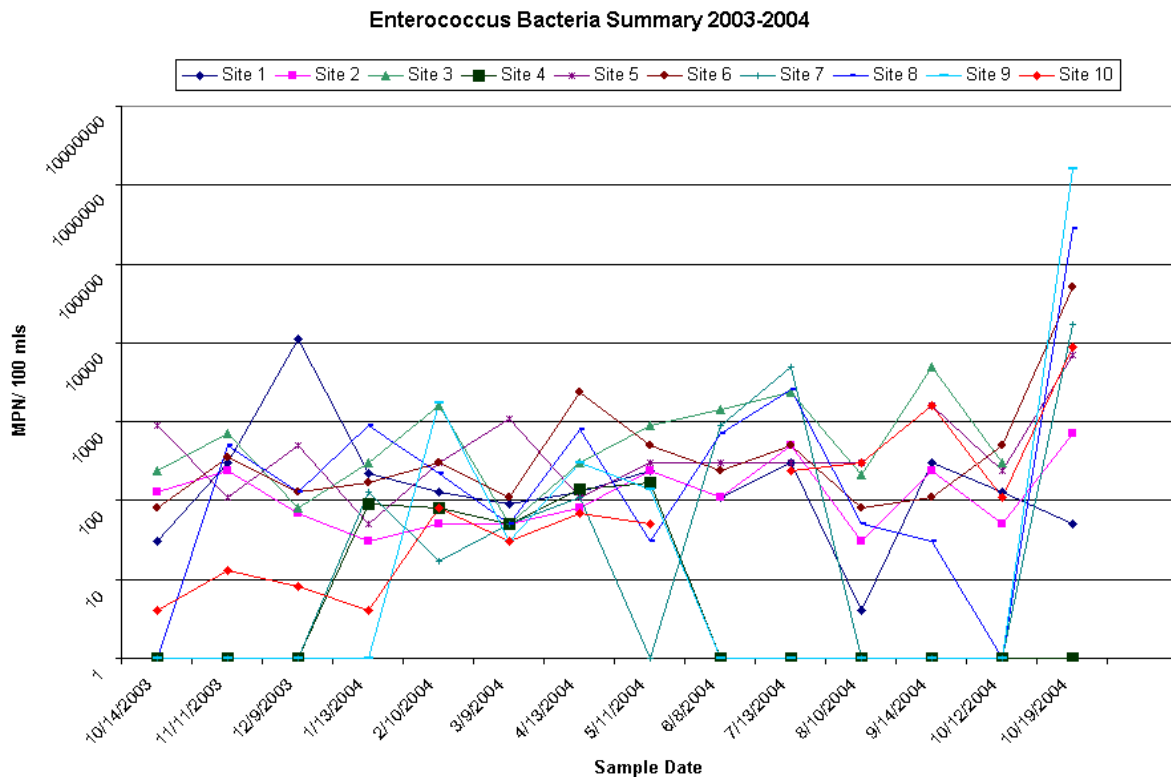
Figure 7. Enterococcus Bacteria from all Topanga Creek Watershed Sites, 2003-04

Enterococcus are found in human feces, as well as that of other warm-blooded animals. It appears to be a more conclusive measure of potential pathogenicity. Comprised of several different species, enterococcus have been found to cause a variety of illnesses in swimmers, including nausea, vomiting, abdominal cramps, and fever. A number of these species include anti-biotic resistant strains, and are a real cause for public health concern. Presently the limit for Enterococcus is 104 MPN/ 100ml before exceedence in marine waters, and a target of <61 MPN/ 100 ml in freshwater.
