GeoPentech

**HYDROGEOLOGIC STUDY
LOWER TOPANGA CREEK WATER SHED
LOS ANGELES COUNTY, CALIFORNIA**

**Resource Conservation District of the Santa Monica Mountains
122 North Topanga Canyon Boulevard
Topanga, CA 90290**

May 2006

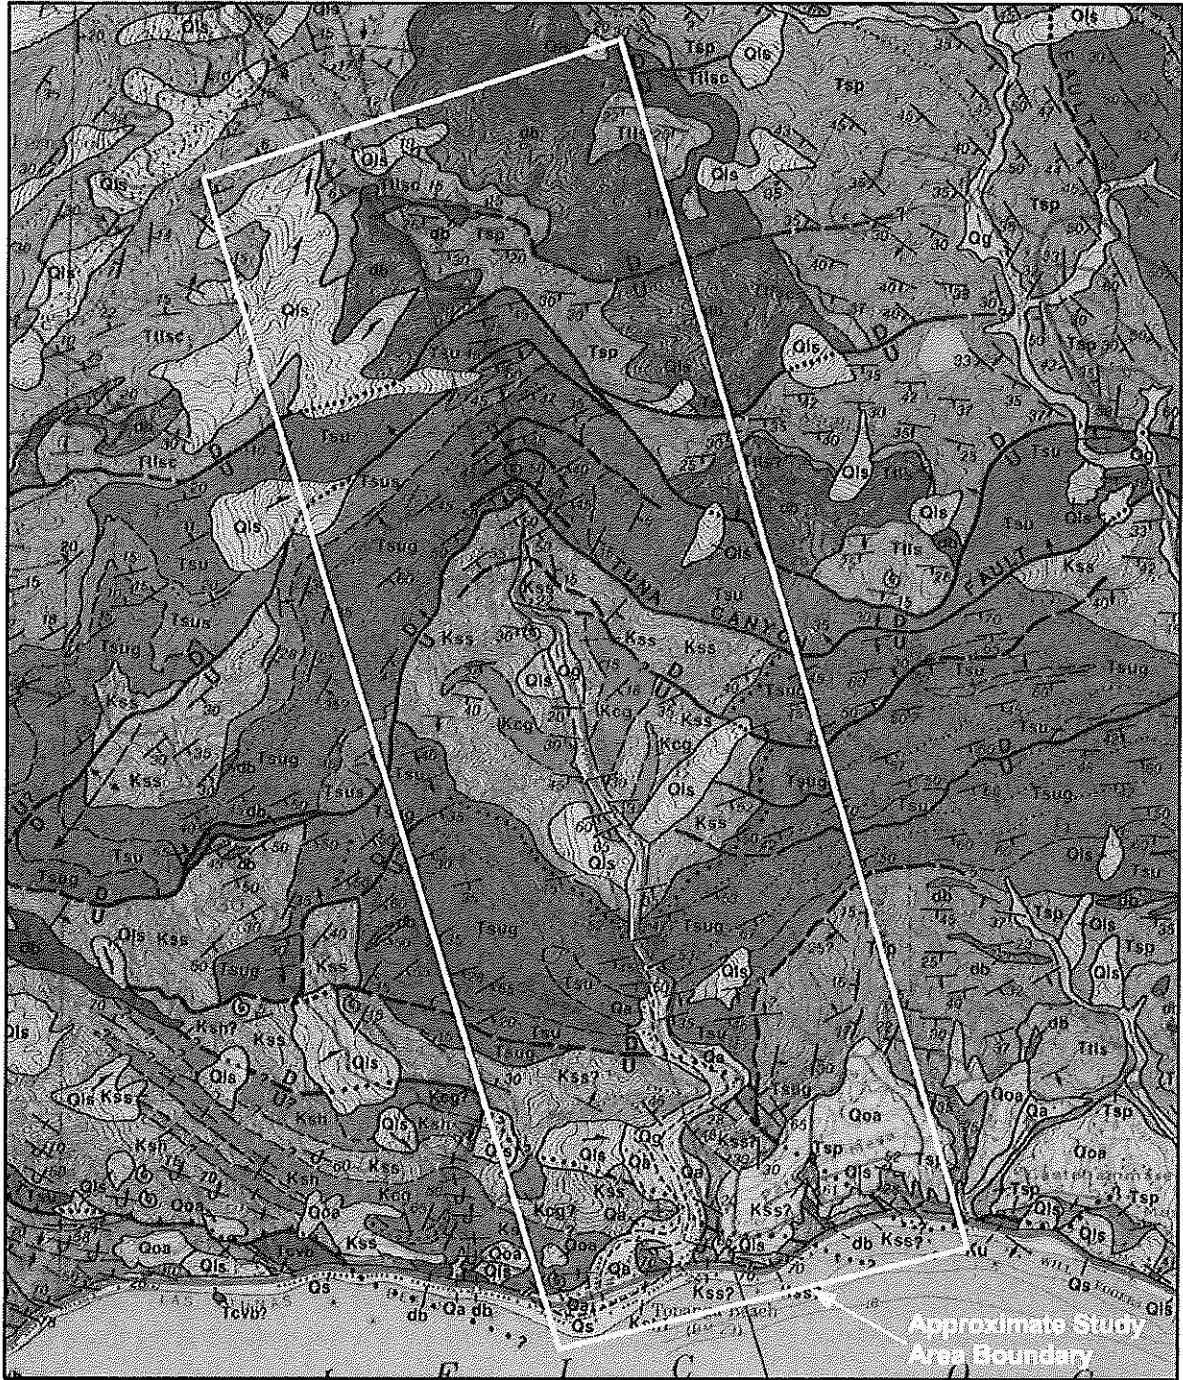
Figure 4a: Geologic Map by Dibblee (1992) of Topanga Creek Study Area

The slopes in the study area are locally covered by Holocene colluvium. The stream deposits along the base of the canyon consist of alluvial gravel, sand, and clay (Qa and Qg on Figure 4). Also, several landslides have been mapped in the region around the study area (shown as Qls on Figure 4a).

Numerous sub parallel faults have been mapped through the study area (shown with heavier font lines on Figure 4a). According to this map, the fault orientations primarily strike between N60E and N80E and dip approximately 35 and 60 degrees to the northwest and southeast. Dibblee (1992) mapped the contact between the Tuna Canyon and the Coal Canyon Formations as the Tuna Canyon Fault. This fault crosses the Topanga Canyon Boulevard near milepost 2.25.

When rain falls on the ground surface, it can travel downslope with little or no infiltration, which is termed runoff, or it can percolate into the subsurface formational material. Within the sedimentary and volcanic rocks that underlie the study area, appreciable groundwater can flow only through the fracture systems within the rock mass. In general, the rock near faults is typically more fractured and may contain clay gouge. This clay gouge may create a barrier in the rock mass system and may direct water to the surface as a seep or spring. Perennial springs are oftentimes related to regional sources of groundwater that upwell along faults and are not as dependent on precipitation. Examples of perennial springs located adjacent to faults were mapped by Dibblee (1992) and are shown on the geology map on Figure 4a.

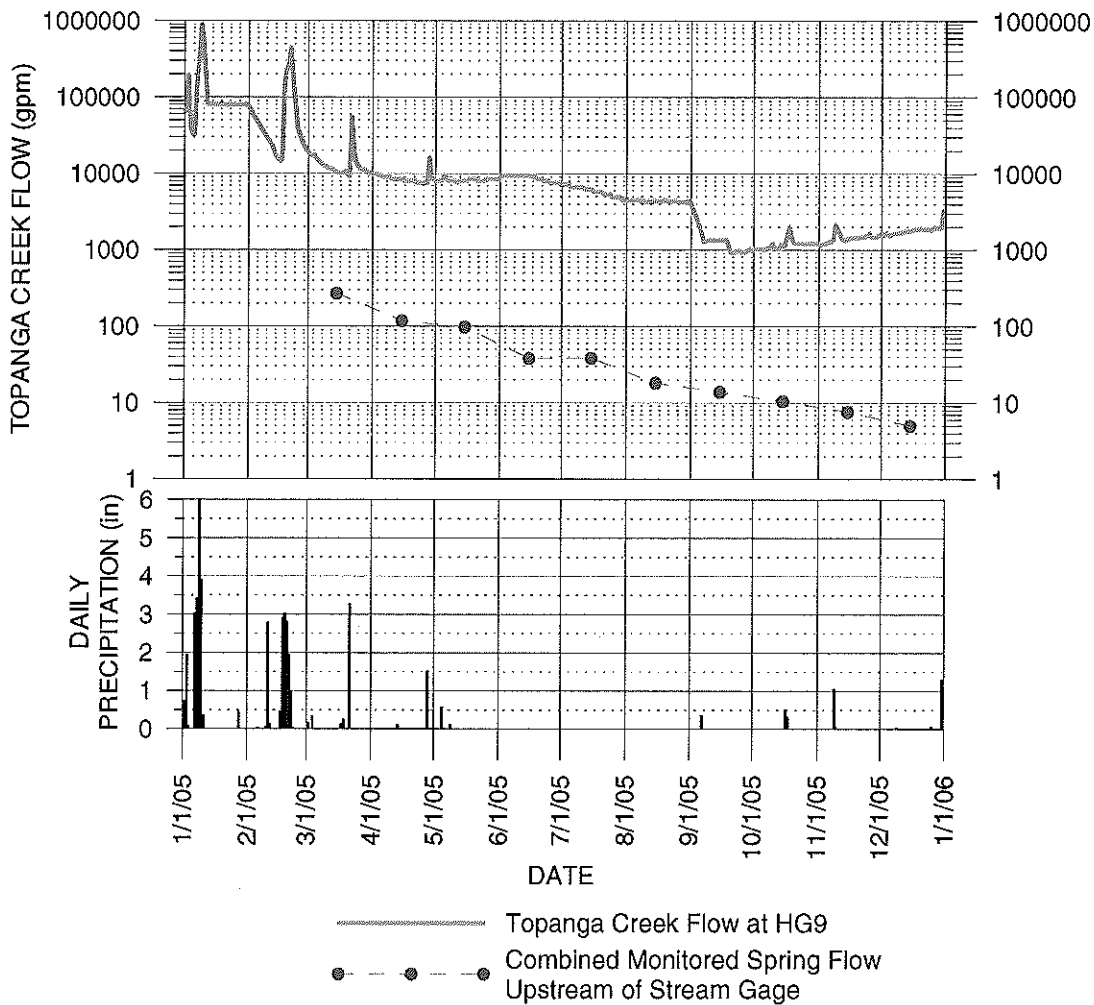
Figure 12: Creek and Spring Flows Within Reach 3

Figure 12 shows the 2005 creek flows monitored at HG9 (Bridge MM 2.02) and the 2005 daily precipitation measured at the Topanga Patrol Station rain gage in the town of Topanga.

As shown on Figure 12, the 2005 Topanga Creek flows measured at site HG9 (Bridge MM 2.02) ranged between approximately 940 gpm and 900,000 gpm. As would be expected, it appears that spikes in the creek flow generally correlate with spikes in precipitation, corresponding to increased rain runoff into the creek. The combined flows from spring sites HG10 through HG23, located upstream of the creek flow gage within Reaches 1 through 3, are also shown on Figure 12. As shown on this figure, the combined spring flows and creek flows follow a similar seasonal pattern, and the combined spring flows are generally 100 times less than the creek flows. This suggests that the input from the monitored springs upstream of the creek's flow gage generally comprise about 1% of the total creek flow; therefore, the influence of the monitored springs on the creek flow volume and chemistry was probably minimal during 2005. It is noted that the springs with the highest flow volume and longest flow durations were selected for monitoring; however, it is recognized that other springs that were not monitored could also contribute to overall creek flow.

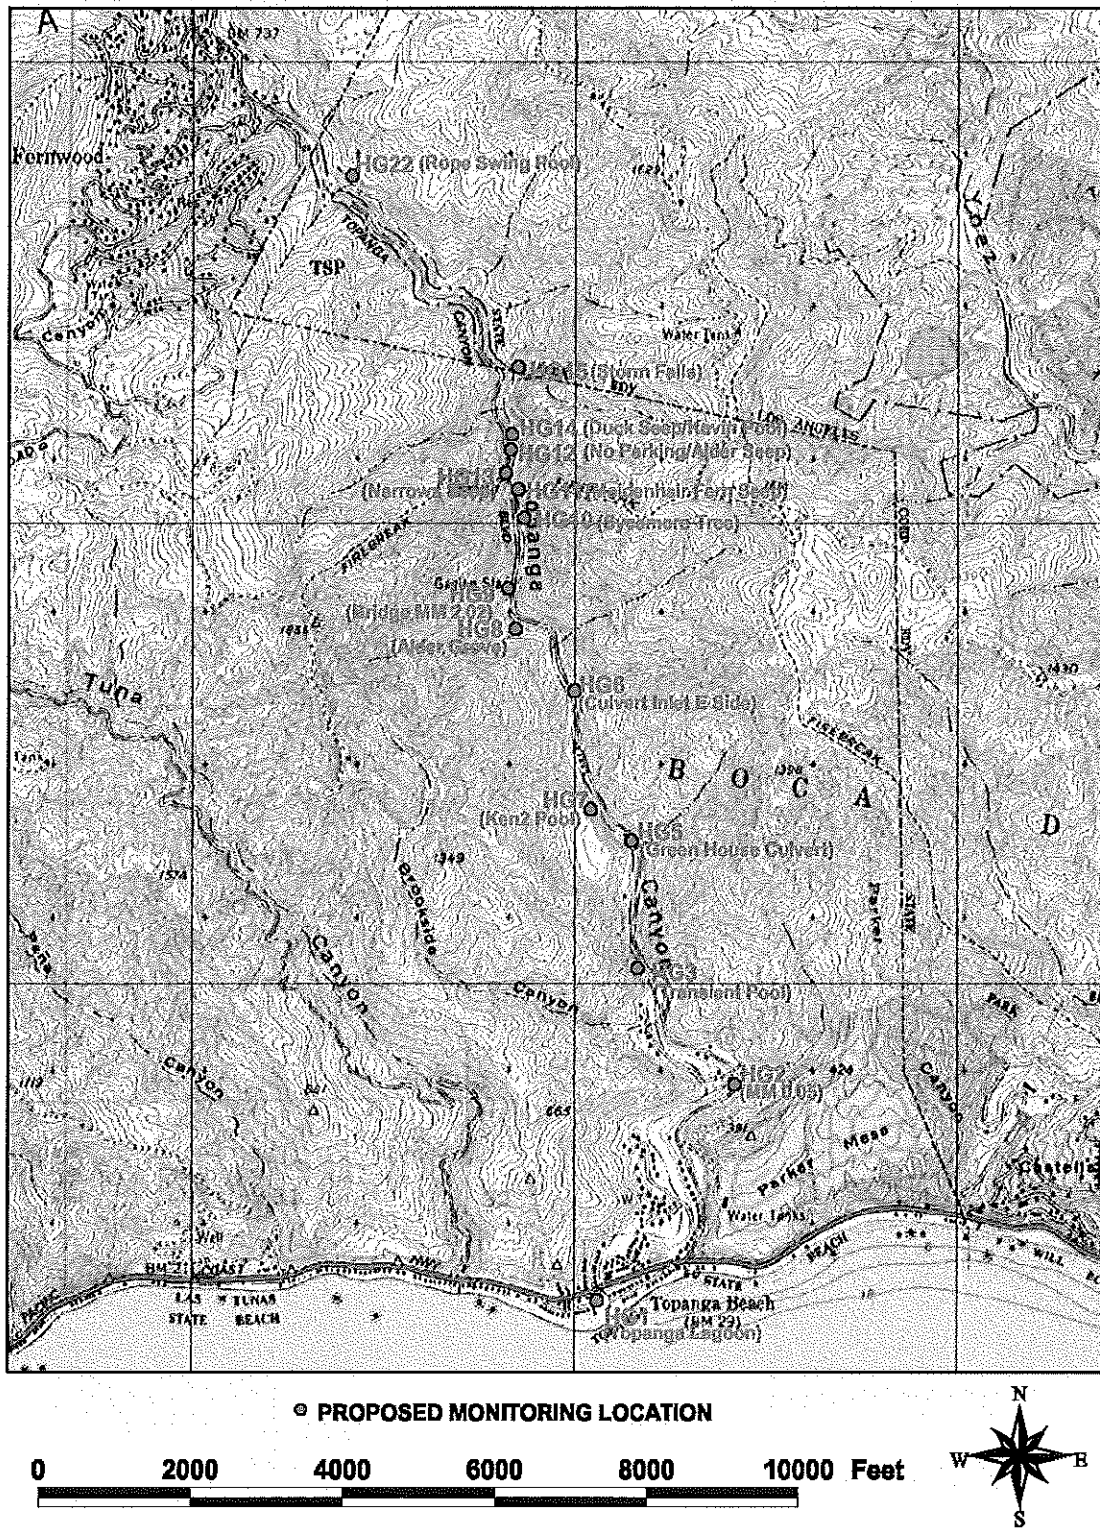
Figure 14: Sites Proposed for Future Monitoring

The following is a general summary of the recommended long-term groundwater monitoring plan.
