Topanga Creek Restoration: Rodeo Berm Removal

Rosi Dagit

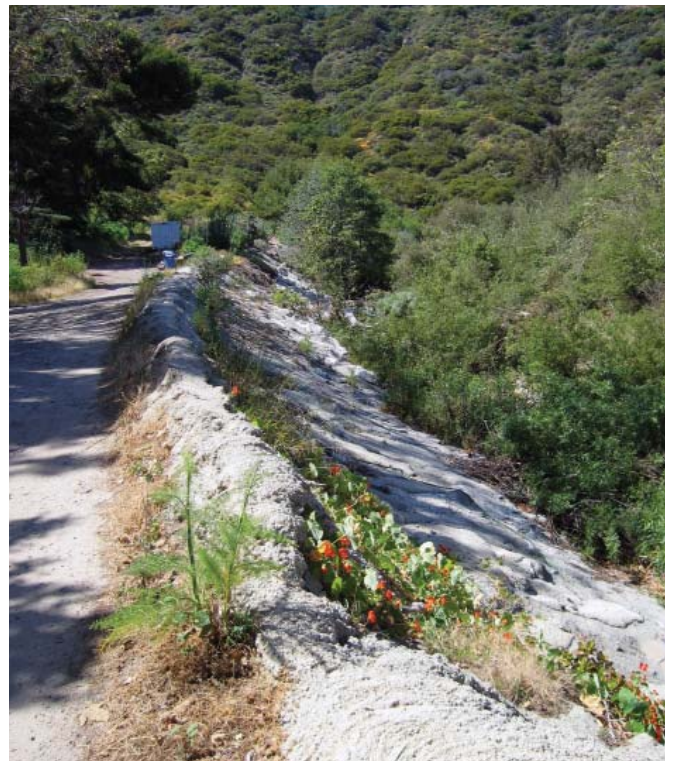
Figure 1. Topanga Creek Rodeo Berm, *Photo: RCDSMM*

The Rodeo Grounds Road Berm was installed without plans or permits in 1969 and rebuilt in 1980 and 1995 by tenants to protect their rental homes from flooding. It was built in several stages, realigning and replacing a lower, smaller dirt road that had been installed in the 1920s (Figure 1). According to local residents, asphalt and paving from the Lincoln Blvd. repaving project were placed on the site in the late 1960s. Additional road spoils from throughout the watershed were added to raise the berm higher following the 1980 flood (Envicom 2006).

The Rodeo Grounds Road Berm was trapezoidal in shape – 1,000 feet long, between 40 to 100 feet wide and between 12 to 18 feet above natural creek grade. The berm bisected the Topanga Creek floodplain in a north-south alignment in a low gradient depositional area 2,500 feet upstream from the interface with the Pacific Ocean at Topanga Beach. The total surface area from toe to toe covered approximately 80,000

square feet (1.8 acres), and the volume of fill material was estimated to be approximately 19,000 cubic yards weighing approximately 26,000 tons (GeoPentech 2005).

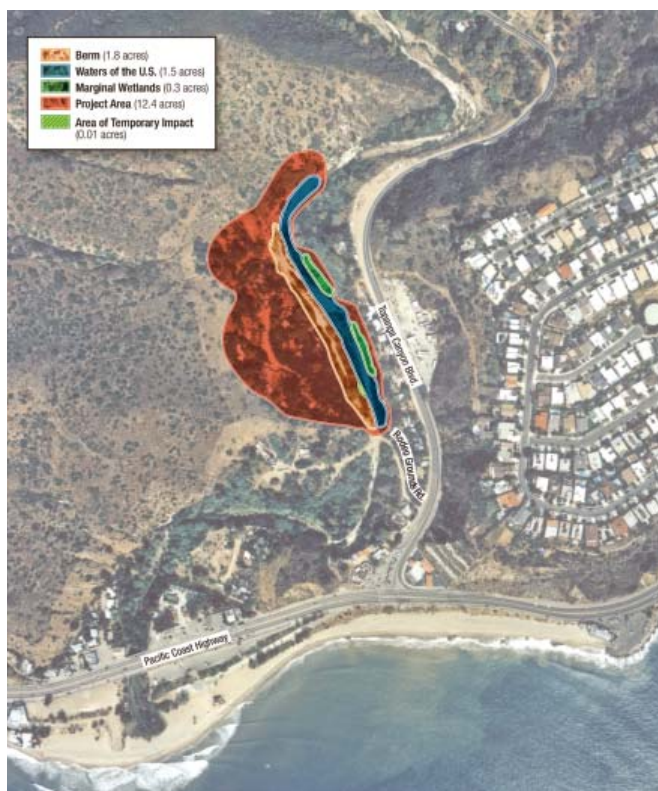
Figure 2. Project Impact Area

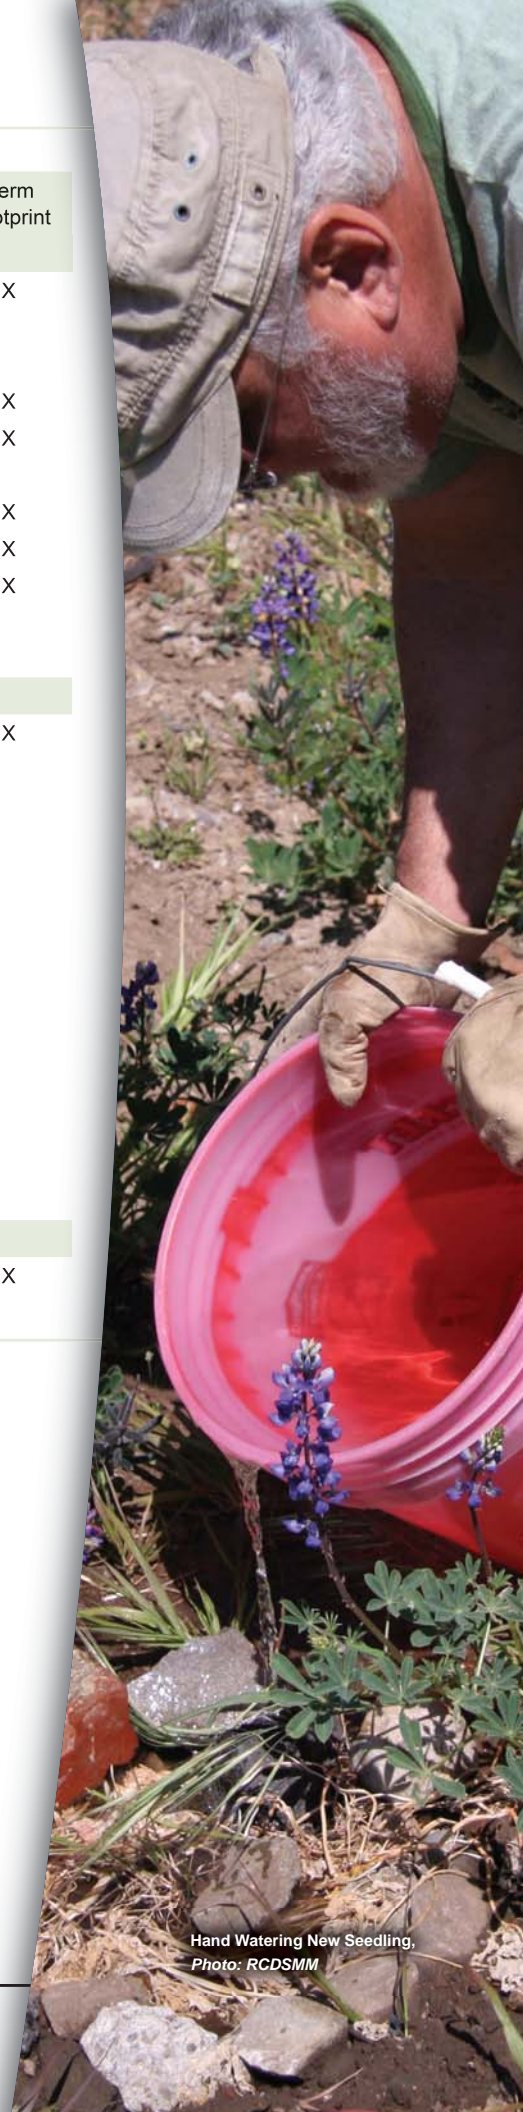
Hand Watering New Seedling,
Photo: RCDSMM

A critical component of the restoration was removal of the existing exotic and invasive species, and re-establishment of native aquatic, riparian woodland, and coastal sage scrub communities. Immediately following excavation, the 40,000 square foot staging, stockpiling, and haul route areas, as well as the newly configured stream bank were hydroseeded with a native seed mix (Table 2). All seeds came from local sources approved by C DPR. Between December 2008 and July 2009, volunteers have contributed over 1,000 hours of time to weed and plant over 400 native plants (Table 3).
